<h1>CONSTGLASS</h1>

<h2>Data sheet for pilot objects</h2>

<b>Object:</b>	<b>Bourges Cathedral, BOU_b4p15</b>	<b>Date:</b> 19.01.2010
<b>OBJECT IDENTIFICATION</b>		
<b>Site</b>	Bourges ( <i>France</i> )	
<b>Building</b>	Saint-Etienne Cathedral	
<b>Location and orientation of the window</b> <b>Plan of the building</b>	<p>Ambulatory, bay 4</p>

<b>Investigated panel (inventory number, CVMA number, size)</b>	Bay 4 Panel 15 (CVMA numeration) Size : 77.5 x 69 cm

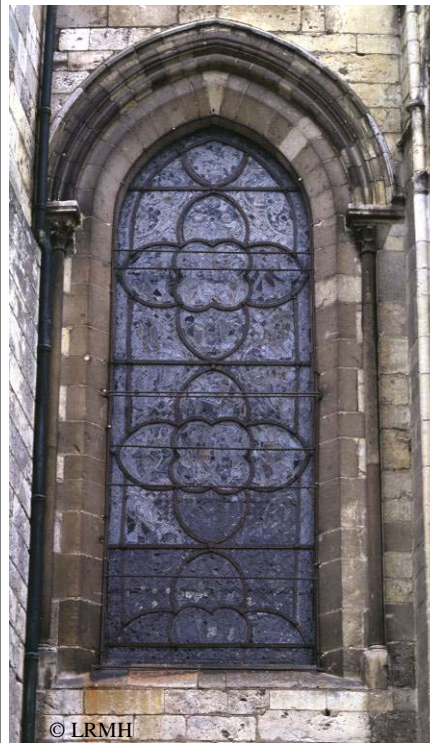
External view

- External wire grilles (iron),
- saddle bars (iron),
- sealant in stone groove (non-hydraulic lime mortar),
- sealant between stained glass panels and supporting framework (linseed oil putty).

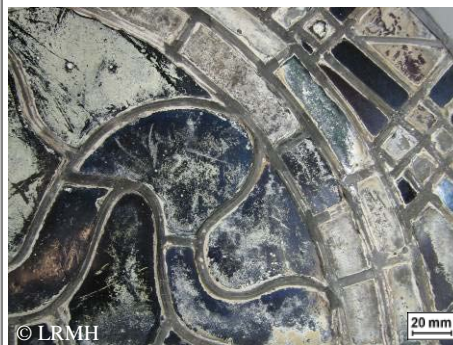
**External face:** No protection on the external surface.

*Glass:* hole and crater alterations, uniform weathering  
*Paint:* no painting  
*Lead:* good condition  
*Putty:* dry and waterproof  
*Coating:* none  
*Deposits:* resumption of the corrosion process

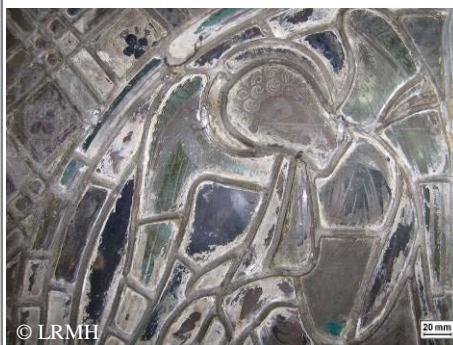
**Internal face:**

*Glass:* it seems to be less deteriorated on the internal surface. There are some holes of alterations dispersed.  
*Paint:* ancient painting with thick line and wash drawing. Brown-red painting (warm brown).  
*Lead :* good condition  
*Putty :* dry and waterproof  
*Coating/consolidant :* none  
*Deposits:* thick, hard white and brownish deposit on most of the pieces: distemper ? mastic residue ? Those deposits often dissimulate the glass corrosion.

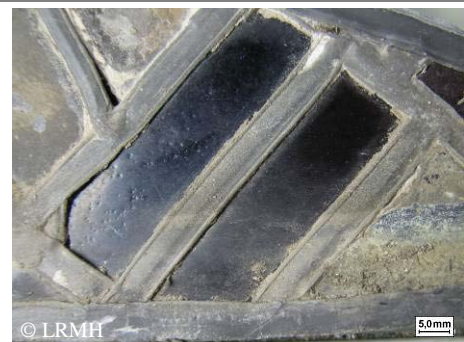
**External surface**

Even on the most recent pieces, process of corrosion has started.
