Data sheet for pilot objects

Object:	Bourges Cathedral, BOU_b4p9	Date:	18.01.2010
OBJECT IDENTIFICATION			
Site	Bourges (France, 18)		
Building	Saint-Etienne Cathedral		
Location and orientation of the window Plan of the building	Ambulatory, bay 4

CONDITION REPORT / DOCUMENTATION IN THE WORKSHOP

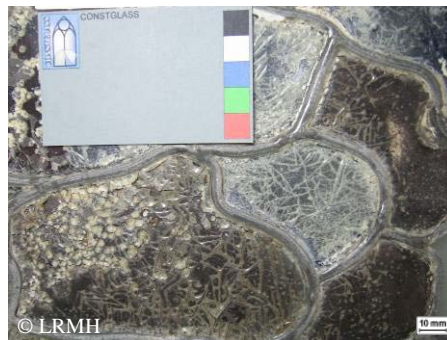
External face: The panel has been coated with Viacryl[®] on the *external surface*. The application has been made with a brush on the glasses and also on the leads. The external surface conserves a large part of altered Viacryl[®] on original pieces. On restoration pieces, there is no more Viacryl, except when located in protected area.

Glass: hole and crater alterations, uniform weathering

Paint: no painting

Lead: good condition

Putty: dry and waterproof

Coating: hard, breakable, yellowed, flaking

Deposits: restart of the corrosion process

This photo shows the support (colour and alteration degree) and the environment (protected or not) have an influence on degradation of Viacryl[®].

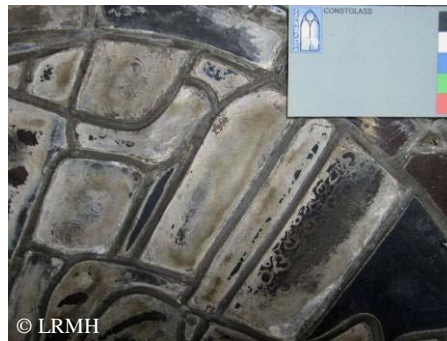
Internal face:

Glass: it seems to be less deteriorated on the internal surface. There are some holes of alterations dispersed. Marks of a previous cleaning with a metal brush on some pieces, but no alteration is visible in the marks.

Paint: ancient painting with thick line and wash drawing. Brown-red painting (warm brown).

Lead: good condition

Putty: dry and waterproof

Coating/consolidant: none

Deposits: thick and hard white (brownish) deposit on most of the pieces, possibly from distemper or mastic residue. These deposits often conceal the corrosion of the glass.

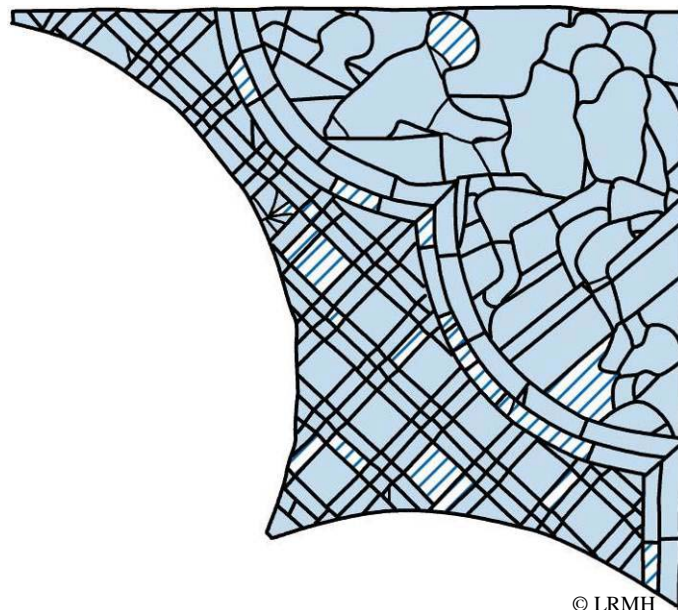
External surface

It remains a lot of Viacryl[®] film on the panel.

Healthy glass is bared where Viacryl[®] peeled off. Under cracks, we can see that glass degradation has grown specifically and make a brown or white alteration lace.

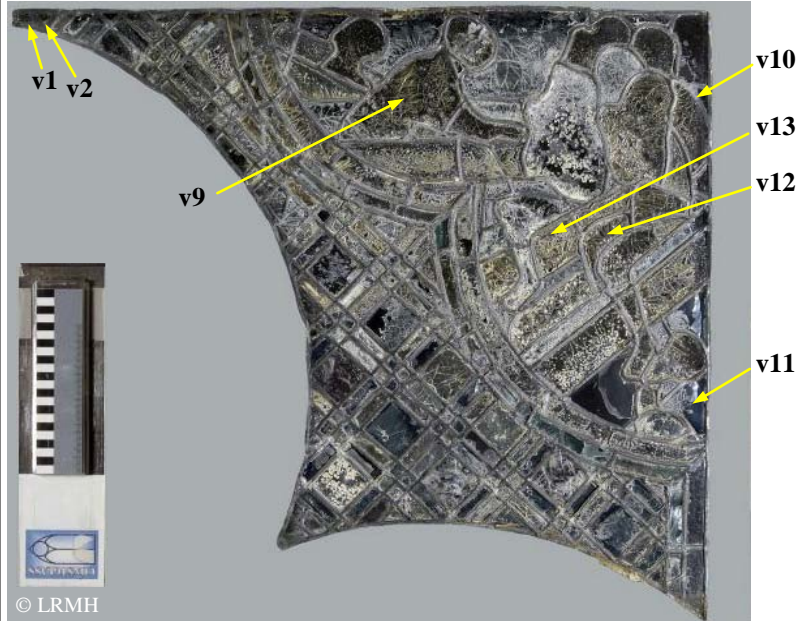
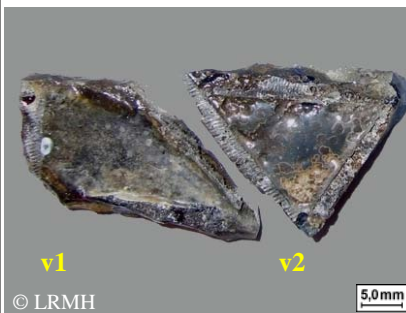
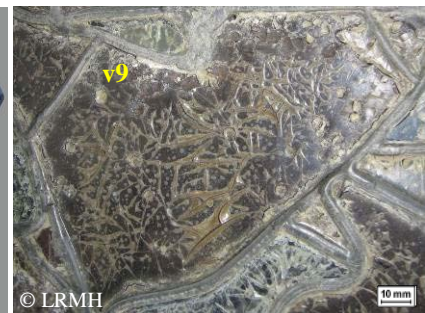
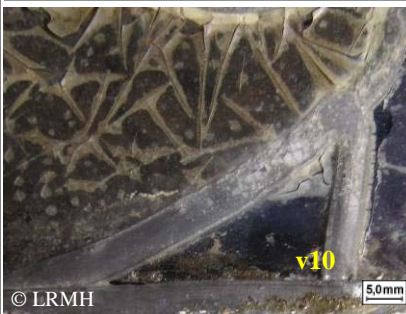
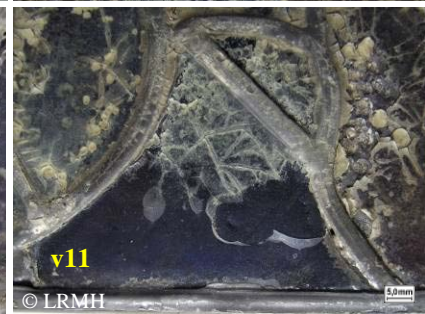
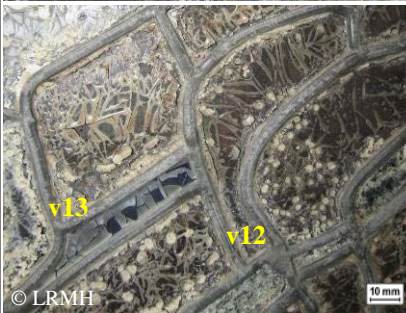
Viacryl® coating on the external face, reflecting light, selected samples :

Is Viacryl® responsible of preferential corrosion (between flakes) ?
