Data sheet for pilot objects

Object: Princess Cecily panel	Date: June 2010
--------------------------------------	------------------------

Short description of the window (identification of subject, artist, workshop)	<p>This small rectangular panel, c.1483, now part of the Burrell Collection, was originally placed at the bottom of the Royal Window in the north-west transept of Canterbury Cathedral, beside the donor-portraits of her parents (Edward IV and Elizabeth Woodville), her two brothers and four sisters, who were alive when the window was being made. On 13 December 1643, following Ordinances issued in parliament earlier that year the window was razed to the ground. The Cecily panel survived and was eventually purchased by Sir William Burrell. The panel was restored in 1975: the photographs, taken in 2010, show the panel in its present condition.</p>
Owner	City of Glasgow
Person(s) in charge	Director, Glasgow Museums
Investigated panel (inventory number CVMA number, size)	Princess Cecily (Burrell Collection, Glasgow. Reg. No. 45/75). 39.4cm x 29.8cm

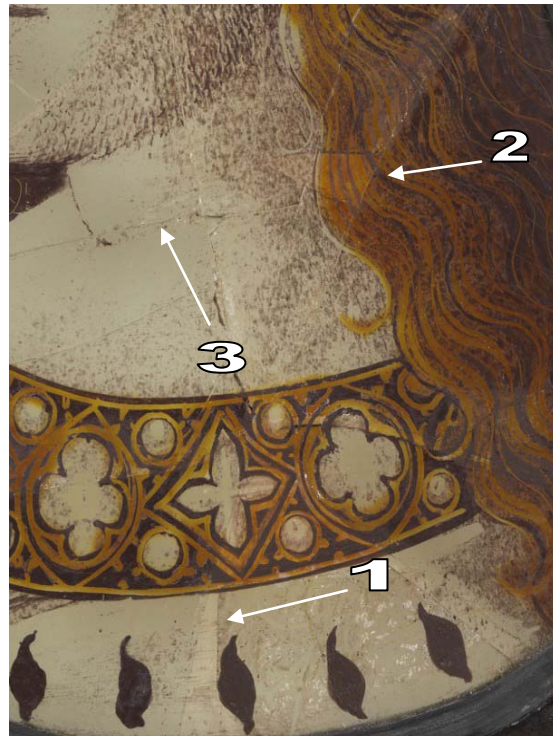
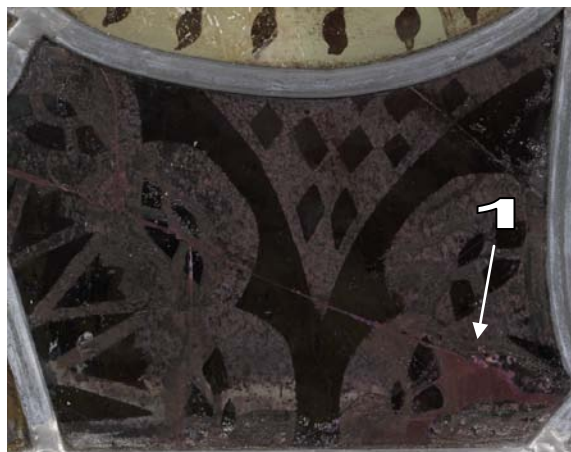
Selected damages

Study focused on repair materials only – they showed excellent durability after 35 years.

Filled (1 and 2 above, 3 below) and bonded (3 above) areas showing good appearance after 35 years
