Data sheet for pilot objects

Object: REF. PARISH CHURCH, TEST - GLASS **Date:** 12.01.2009

Site Burgdorf BE (Switzerland)

Building Ref. Parish Church

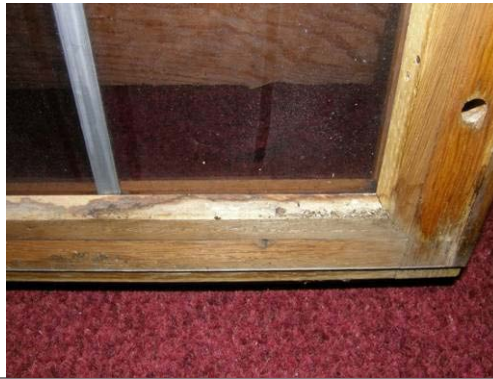
Picture 2

The climate in the vestry of the parish church is rather humid and moderately heated. The wall shows signs of humidity, at some places the wall plaster is peeling off. Occasionally, condensation occurs in the inter space of the glazing, leaving marks on the window frames. (Pict. 2).

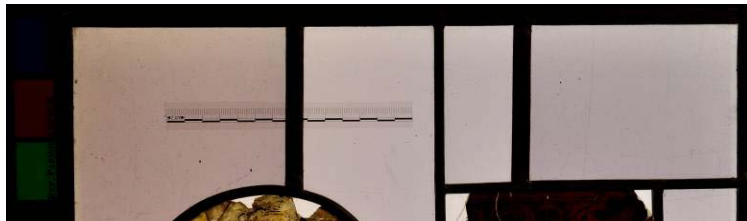
The panel is slightly bending due to heat dilatation. A small timber wedge had been applied under the lower lead bar, which caused a deformation of the panel.

The objects are exposed to UV-Light, through a 3mm-float glass.

Around the fragments, K. Vetter used some glass colored with manganese. This glass has changed color (to violet), according to its exposure to UV. The upper border, which has certainly less sunlight, is less affected.

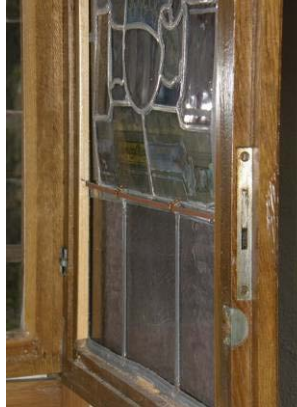
The panel was fixed in a timber frame with wooden strips.

For an easy removal, the front frame holding the protective glazing was fixed with two screws. The wooden strips around the glass panel were fixed with nails.

Two iron bars are fixed on the outside of the panel.

There is sawdust in the inter space.

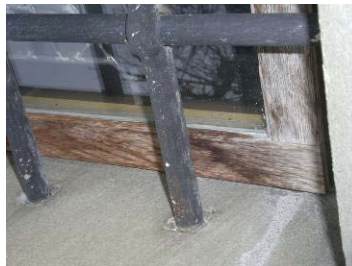
Outside of the protective glazing, protective ferramenta.

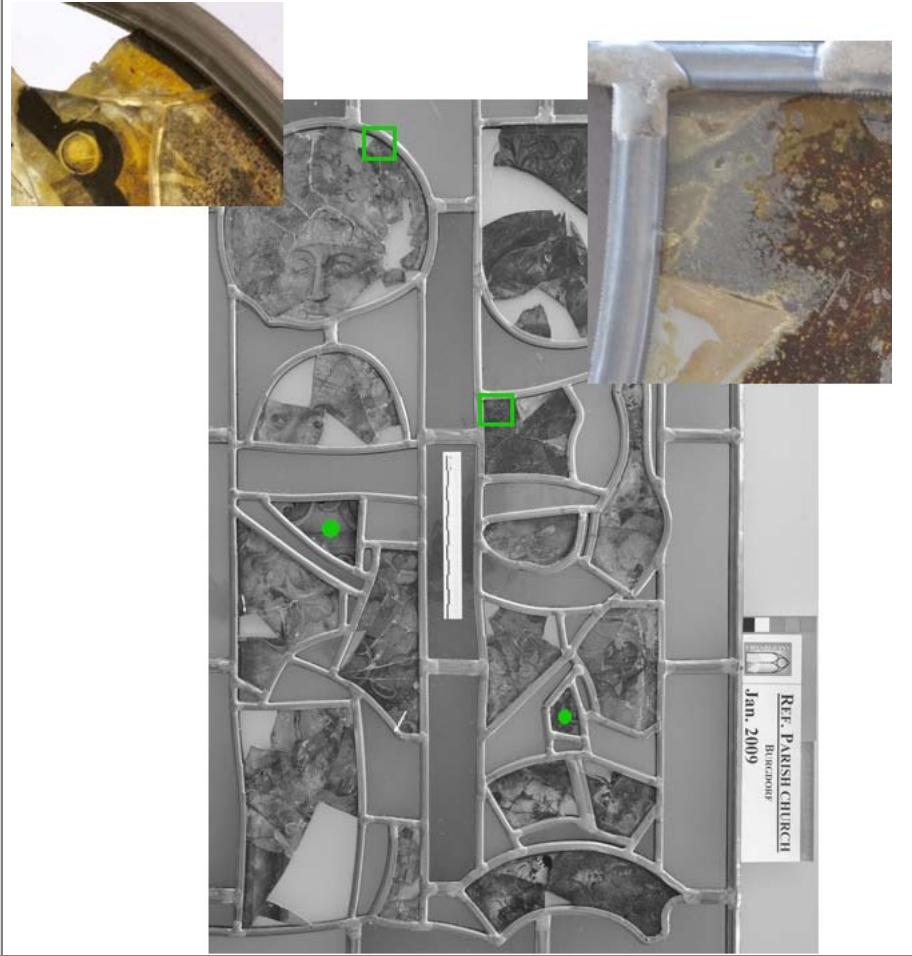
object (if possible with microscope)	<p>Short: The glass is in stable condition. On the (laminated as well as open) external surfaces some pitting corrosion.</p> <p>The paint is stable. Some paint loss.</p> <p>The lead is a perfect condition. The putty is in a good condition.</p> <p>The Araldite® is yellowing and in some places loses adhesion / flakes off, showing clearly different types of deterioration.</p>
Selected damages	<ul style="list-style-type: none">● fragment without doubling / pitting corrosion□ selected damages for samples / pitting corrosion in Araldite®

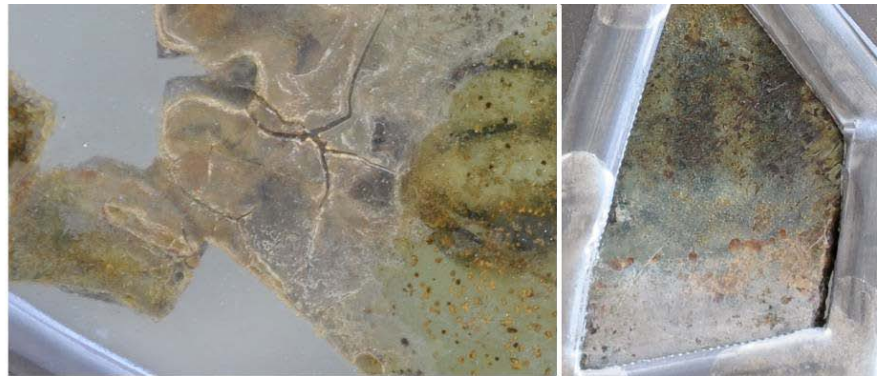
Selection and documentation of samples to be	<p>Is there a difference between the pitting corrosion with Araldite® and without?</p>
