CONSTGLASS

Data sheet for pilot objects

Object: CAN NXVII C1	Date: 10/05/10
-----------------------------	-----------------------

OBJECT IDENTIFICATION	
Site	Canterbury, UK
Building	Canterbury Cathedral
Location and orientation of the window Plan of the building

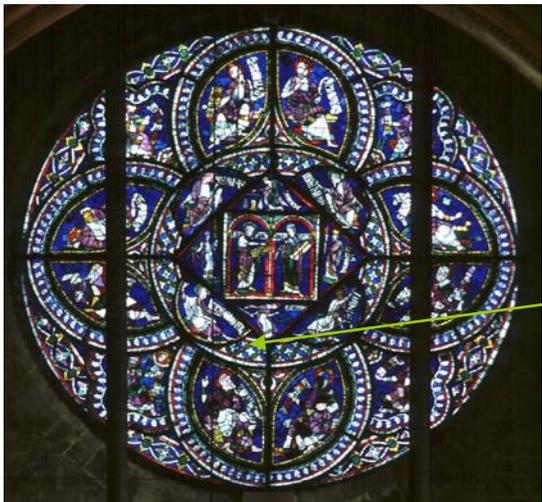
<p>Oculus Diameter: 4.47m</p>

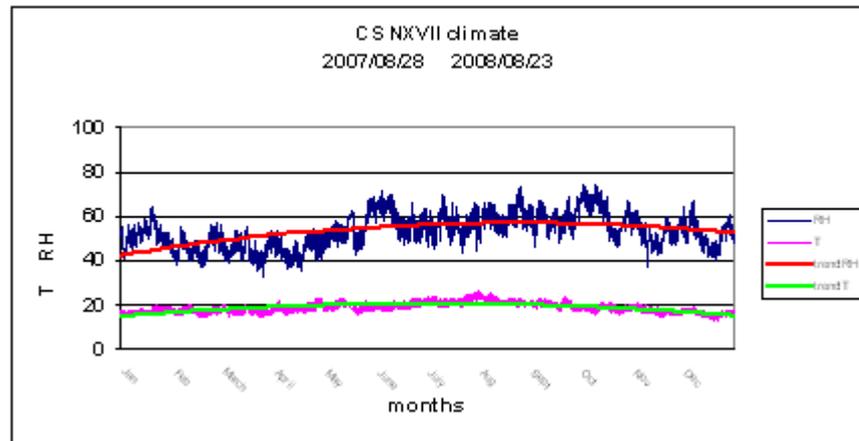
fig.1 CS NXVII climate

The plot shows that climatic conditions of the NXVII window are very stable through the whole year. Both T and RH levels are on the safe side and it seems that neither condensation nor wetness may occur.

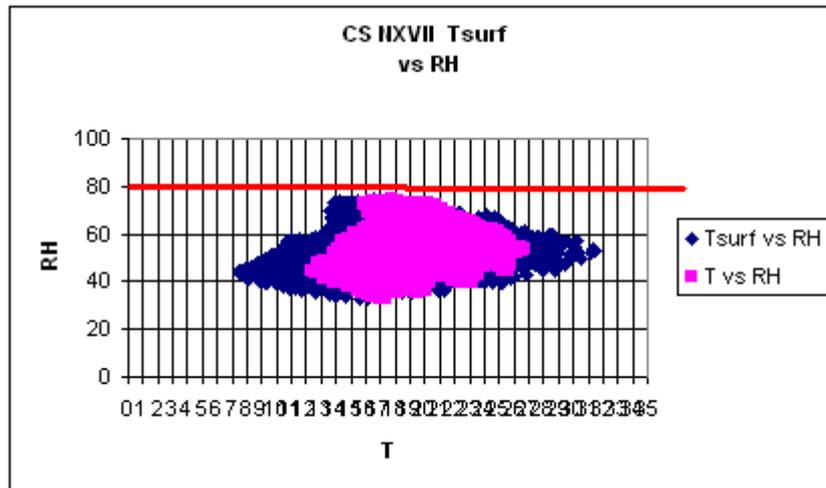
fig 2 CS NXVII climate: T vs. RH and Tsurf vs. RH

The graph depicted on fig. 2 visualizes the possibility of wetness of the glass occurring when $T > 0^{\circ}\text{C}$ and $\text{RH} > 80\%$. Two sets of data: T (air) vs. RH and T surf vs. RH were compared. The graph shows, that, although a range of temperatures is wider for surface a surface, RH never reaches 80%. Taking into account possible differences between RH of air and RH close to surface, the possible wetness may occur, when T lies within 13 - 21 $^{\circ}\text{C}$.

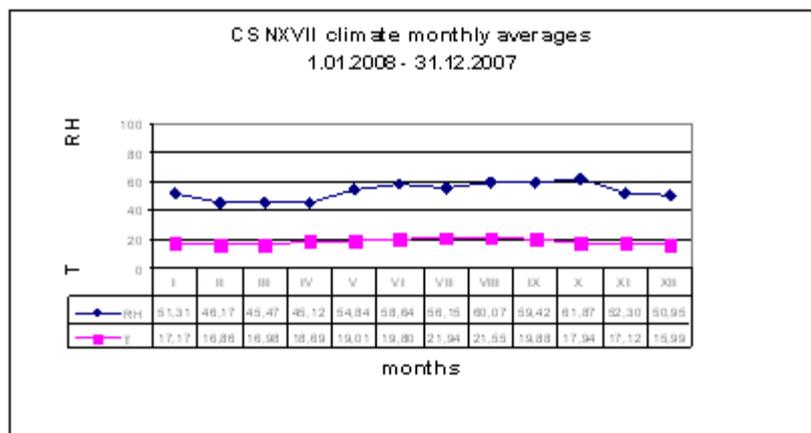
fig. 3. CS NXVII climate : monthly averages

The mean monthly values of T and RH confirm a good stability of NXVII window climate. The climate of window NXVII is quite stable and condition for stained glass windows are very good.

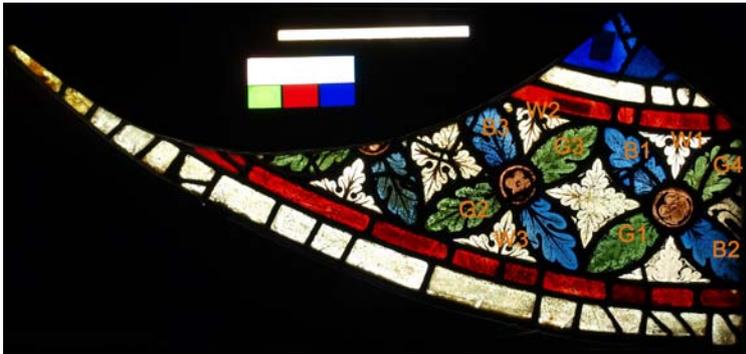
<p>B1, G1, G4 and W2 consolidated with SZA B2, G2, and W1 consolidated with Ormorcer® and Paraloid® B72® B3 and G3 consolidated with Paraloid® B72</p>
