Data sheet for pilot objects

Object: CAN SXXVIII 8h South West Transept

Building Canterbury Cathedral

SXXVIII 8h

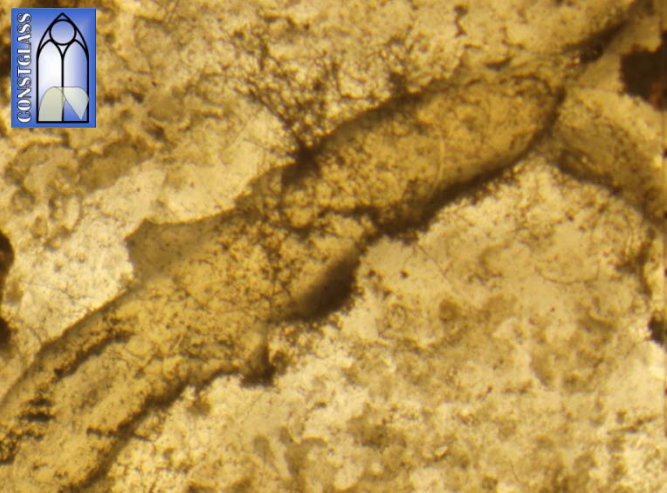
Silicone repair (face) transmitted light

Dust accumulation on silicone bonds, suspected microbial activity.

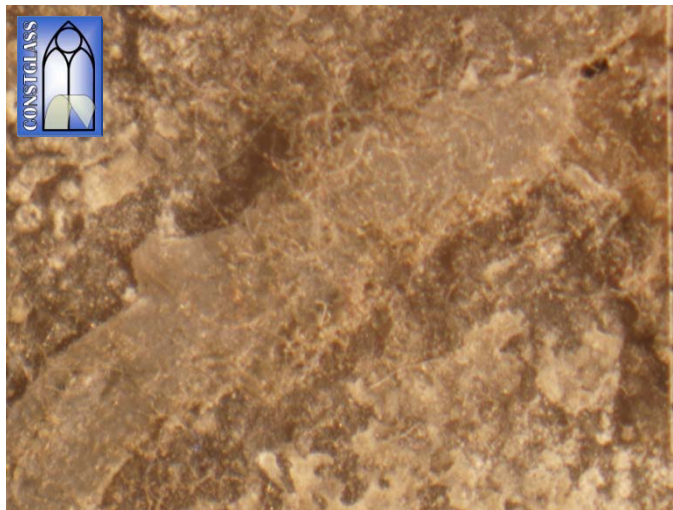
Silicone repair (face) reflected light
