Data sheet for pilot objects

Object: CAN nII 7	Date: 10/05/10
--------------------------	-----------------------

OBJECT IDENTIFICATION		
Site		Canterbury, UK
Building		Canterbury Cathedral
Location and orientation of the window Plan of the building		North aisle, Trinity chapel

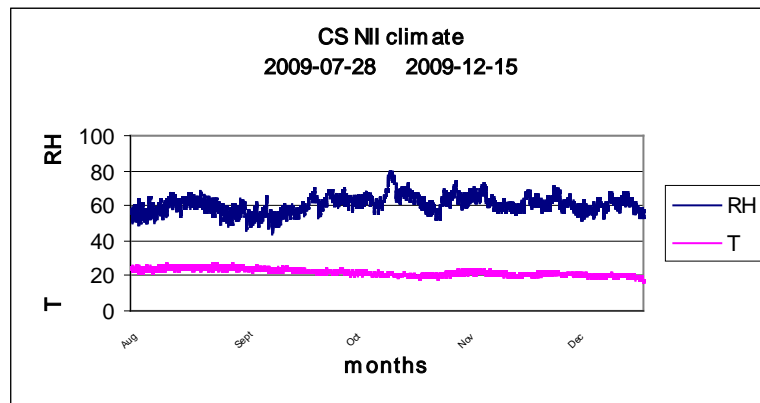
fig.1 CS NII climate

The graph shows that climatic conditions of the N II window rather stable, although the RH variations are more apparent than on other windows. Still both T and RH levels are on the safe side, but in October the short rise of RH occurred, which might cause a short wetness phenomenon.

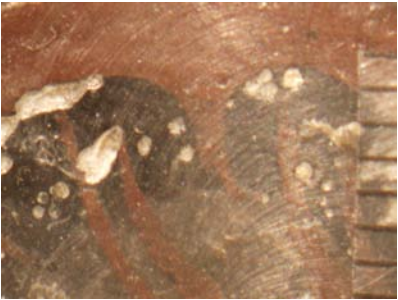
<p>Wax coating on painted decoration.</p>

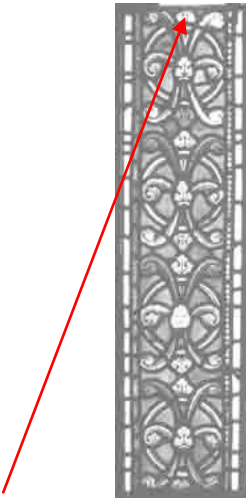
<p>Sample taken from the area shown by arrow.</p> <p>Can the interface between wax and decoration / glass surface be visualized?</p>
