Data sheet for pilot objects

Object: CAN sVII 4	Date: 10/05/10
---------------------------	-----------------------

OBJECT IDENTIFICATION	
Site	Canterbury, UK
Building	Canterbury Cathedral, Trinity Chapel ambulatory
Location and orientation of the window Plan of the building

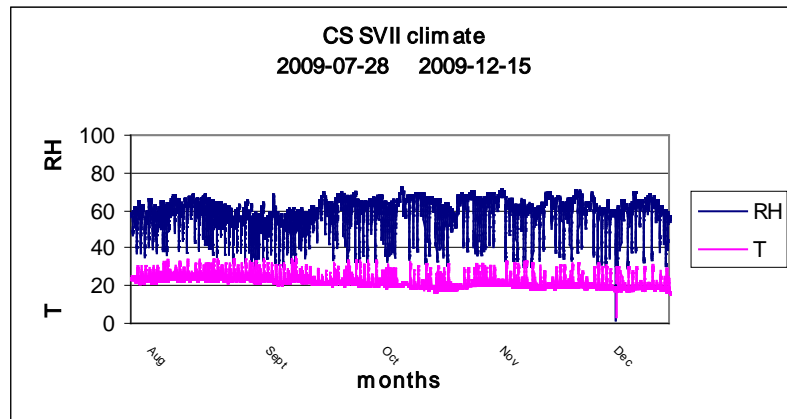
fig.1 CS SVII climate

The graph shows that climatic conditions of the SVII window are very stable through the measurement period and. both T and RH levels are on the safe side and it seems that neither condensation nor wetness may occur.

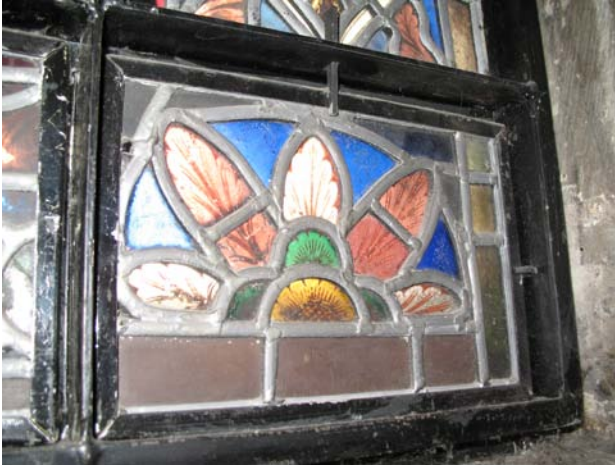
<p>Requirements for a safe removal in respect of minimal intervention</p>	<p>Handling with gloves, the panel was kept upright at all times.</p>
<p>Environmental causes for damage</p>	<p>Since the protective glazing was installed in 1984 there has been no condensation on the historic glass, though dust has accumulated on the surface.</p>
<p>Short report of removal</p>	<p>Handling with gloves, the panel was carefully removed from the frame. The putty seal had to be removed with a knife.</p> <p>In situ.</p>

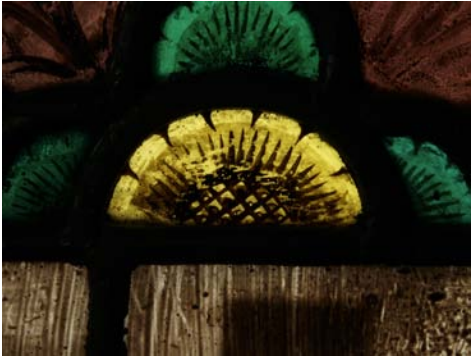
<p>Wax swab tested for microbiological analysis.</p>

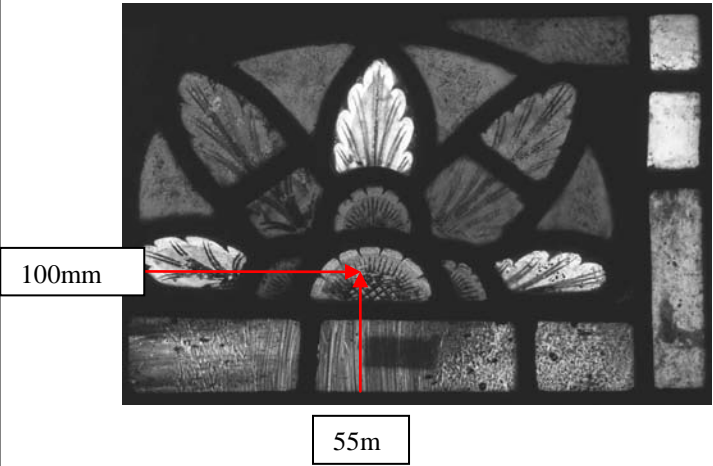
<p>Selection and documentation of areas for reversibility tests or reactivation tests</p>	<p>Sample was taken from the area shown by the arrows.</p> <p>Has there been/ is there any microbial activity?</p>
