Data-sheet Klausen

Object: Parish Church in Klausen (Eifel)	Date: 15. 12. 2008
---	---------------------------

OBJECT IDENTIFICATION	
Site	Klausen (Germany)
Building	Parish and Pilgrimage Church
Location and orientation of the window	Axial window in the choir, faced to the east

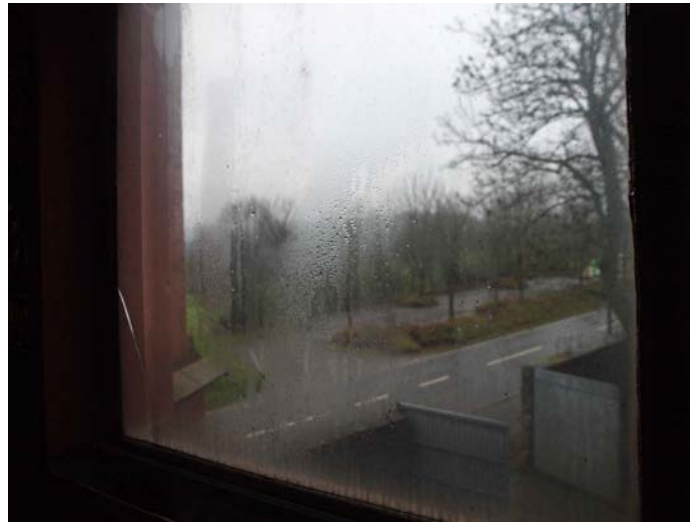
The ventilation in the interspace is obviously not sufficient. During the actual removal we saw water drops on the surface of the protective glazing and on the external side of the original panel.

Outer protective glazing with water drops on the inside surface.

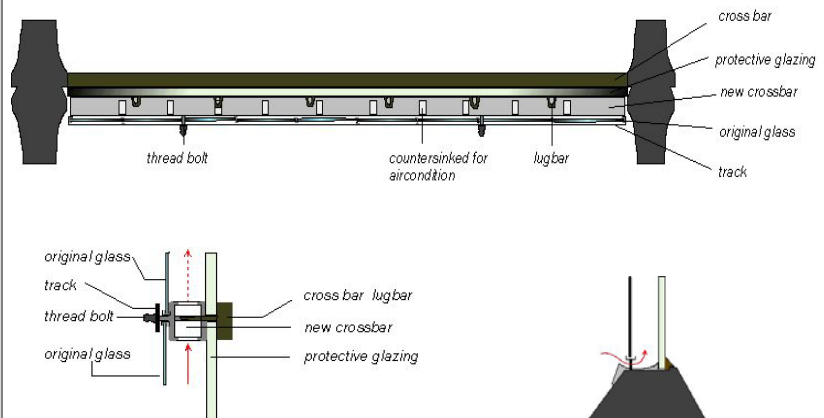
Construction of the outer protective system:

Surround materials and construction related materials	Before the protective glazing system was installed, the window was surrounded by red sandstone. The panels were inserted in the grooves and fixed in mortar. After the installation of the outer protective system in 1991 the window panels were internally mounted on a new steel construction. Each panel is now framed with U-profiles of brass.
--	--

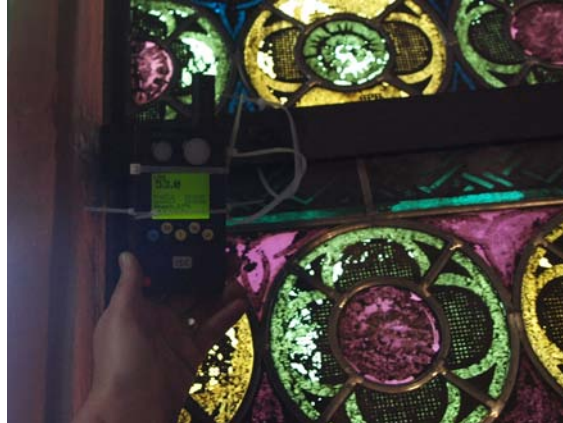
Data-logger exposed on panel 1c

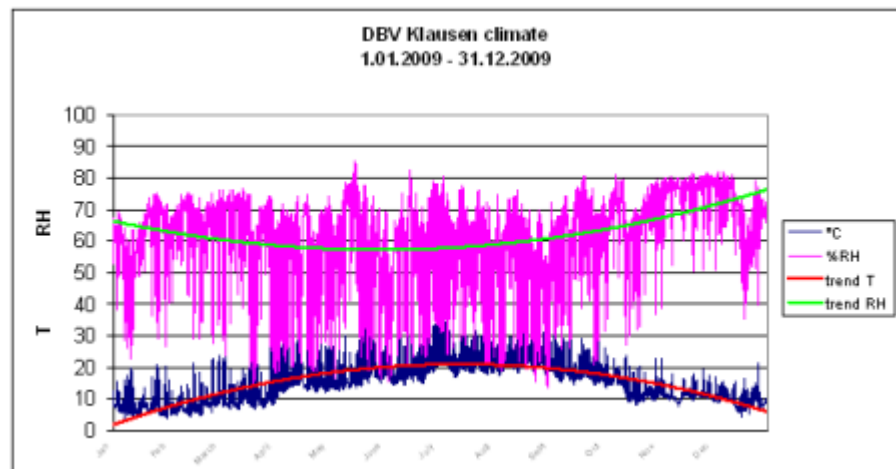
fig.1 Klausen climate

The plot shows that RH tendencies depend on season of the year: in warmer, summer period of the year, the RH averages drop down with rise of air temperature. This may suggest, that there is no additional input of water vapors from more humid outer climate.

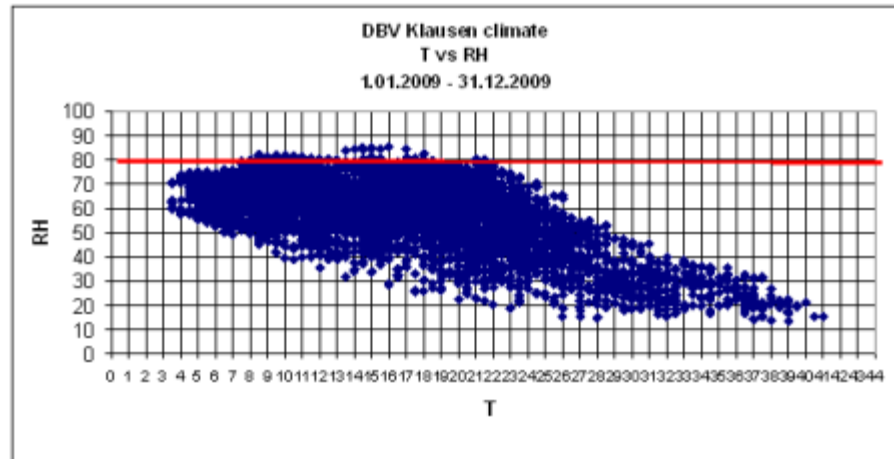
fig 2. Klausenr climate: T vs RH

The graph depicted on fig. 2 visualizes the possibility of wetness of the glass occurring when $T > 0\text{ }^{\circ}\text{C}$ and $\text{RH} > 80\%$. The graph shows, that wetness may occur within the 8 to 22 $^{\circ}\text{C}$ range. It seems that this phenomenon may occur quite often.

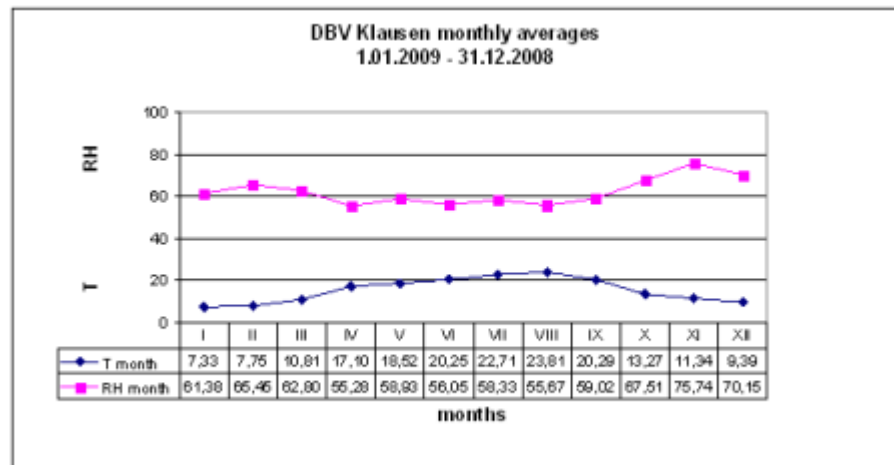
fig. 3. Klausen climate: monthly averages

The mean monthly values of climate data follow the trend lines of plot 1 and also show, that probability of wetness occurrence is higher in the colder seasons of the year, particularly in late Autumn and winter period .

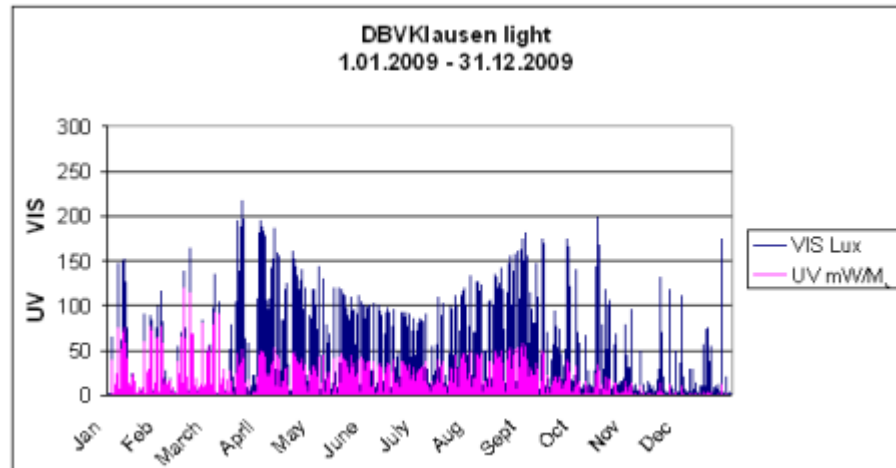
fig. 4. Klausen visible and UV light levels

The lowest level of light occurs in summer. This phenomenon, rather astonishing for the first glance may be caused by high sun path in summer, leading to shading the area where logger was situated. The UV level is very low throughout the year. There is also low VIS illuminance during cold season of the year.

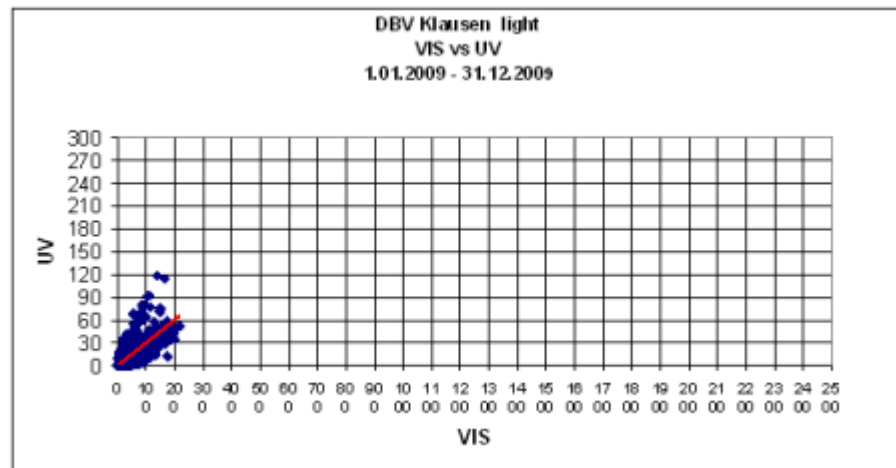
fig 5. Klausen light: VIS vs. UV

The graph shows, that the both, illuminance and irradiance are low and the range of them is narrow.

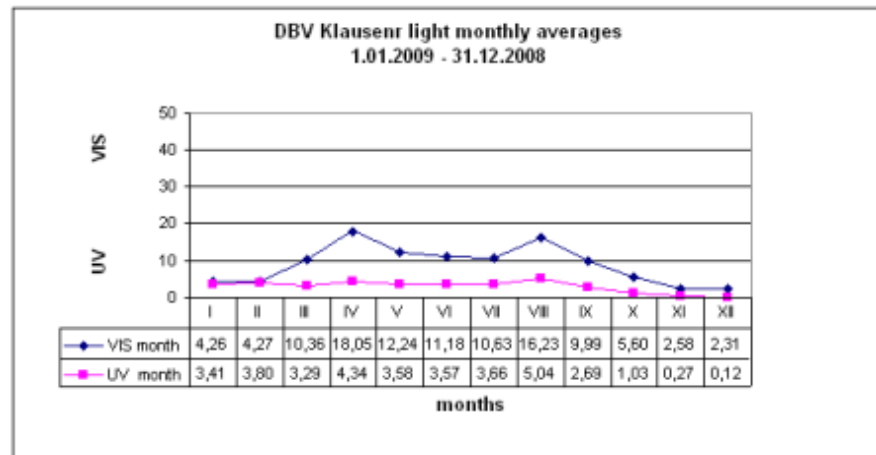
fig. 6. Klausen light: monthly averages

The UV radiation is low, the VIS light shows two peaks in April and August and low level of light in winter.

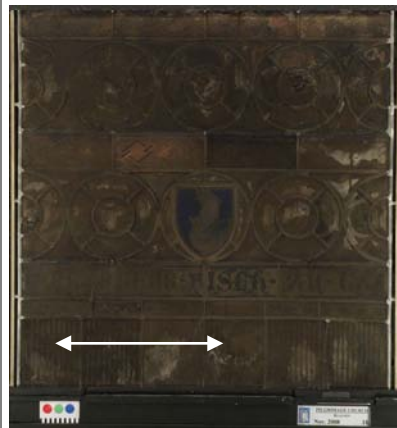
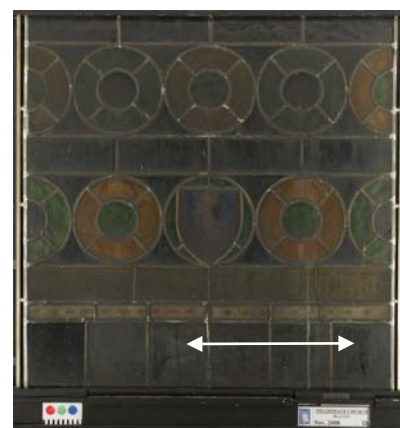
The internally coated glass is obviously in a good condition compared to 1991. Only some small particles of the paint became loose. Unfortunately, in 1991, the company which carried out the general conservation treatment (Firma Binsfeld, Trier, D) did not pay much regard for the SZA/Ormocer®-treated test panel, especially for the endangered paint. They applied several cello-tapes on the internal face, maybe for securing cracks (we do not know why). Two of the cello-tapes were detached by somebody; here the SZA/Ormocer®-treated contours were badly damaged.
