Data sheet for pilot objects

Object: Smolensk 9 st. – pilot object

Date: 15.05.2008

Building *Smolensk 9 (former Industrial Museum)*

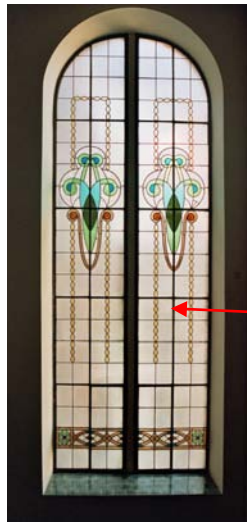
C - third floor: dim: x=90 cm; y=400 cm

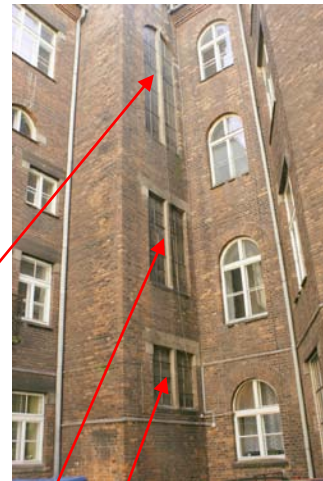
B - first floor: dim: x=90 cm; y=240 cm

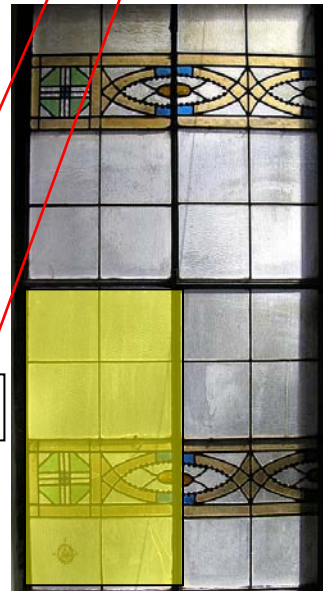
A

A- ground floor (pilot object) dim: x=90 cm; y=160 cm

Pilot window and pilot panel marked yellow

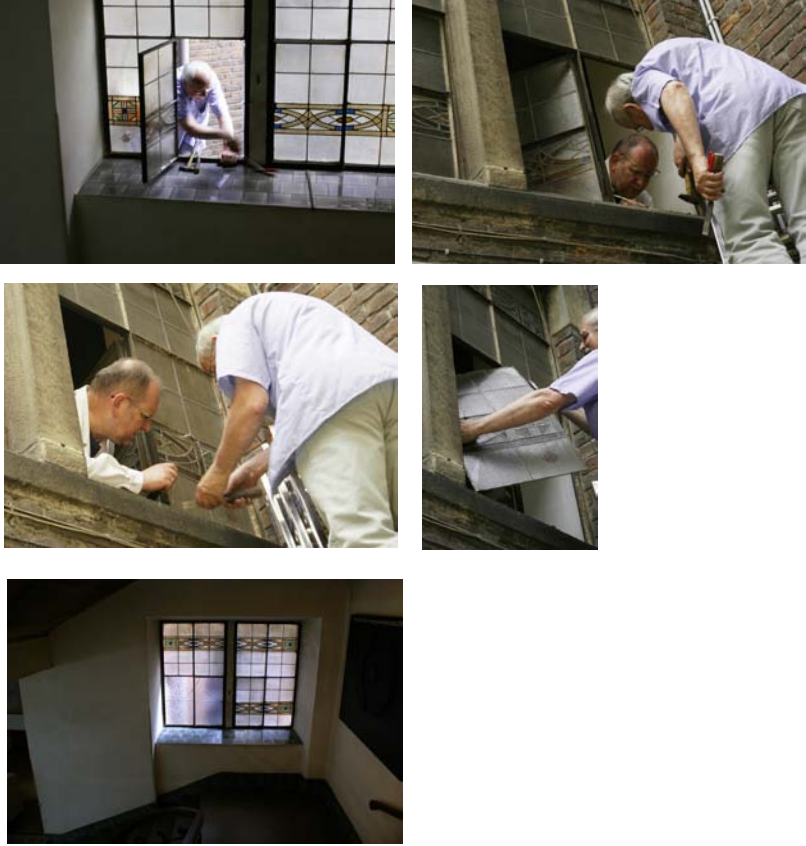
<ol style="list-style-type: none"> 1. Dismantling from outside and inside 2. Three persons needed 3. Sealant crumbling and missing 4. Due to panels design do not bend! 5. Since leading is nearly one hundred years old, may be very weak. 6. No scaffolding necessary
<p>Environmental causes for damage</p>	<p>Air pollution – gaseous and solid Splash water from outside Higher humidity - due to orientation and isolation</p>	
<p>Short report of removal</p>

<p>The test panel was removed by three persons. After removing the sealing putty (hard, but crumbling easily) with chisel, the saddle bars were removed and the panel dismantled. No particular problems occurred. The opening was temporary protected with cathedral glass</p>
Short report of transport	<p>As the test site is situated close to the conservation laboratory no special packing was required. It was transported with a car, in a boot. Panel was laid flat on the soft particleboard, protected from the top with another one and secured with a tape. The whole transportation took 5 minutes.</p> <p>The surface of the test panel was neither treated nor touched.</p>

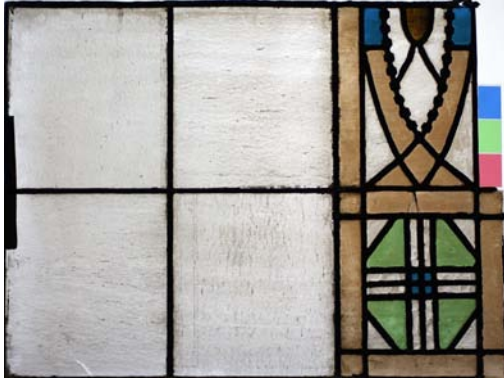
<p>Daylight. Due to weak leading part of the test panel had to be dismantled.</p>
Pictures of panel / glass in reflecting and raking light, internal and external surface

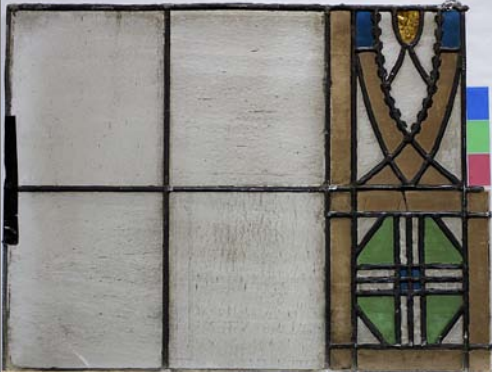
<p>Fluorescent- daylight external surface</p>
Examination of the object (if possible with microscope)	<p>Glass not visually corroded on neither side. Dark deposits (soot, industrial dust) outside. Dirt (domestic dust) from inside. Traces of its cleaning with wet rag.</p> <p>Sealing putty partly missing, crumbling.</p> <p>Leading too thin for such a panel. Locally broken. Very weak.</p>

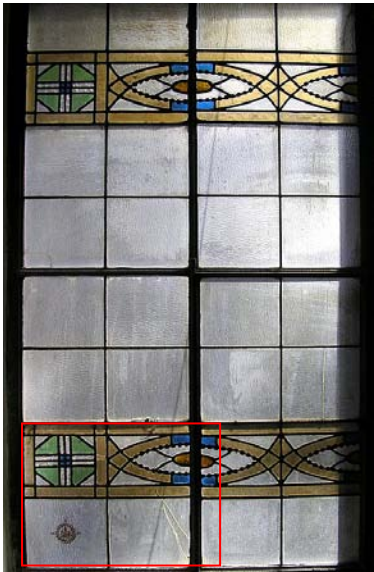
<p>Sample 1</p>

<p>broken glass repaired with epoxide putty</p>
<p>Selection and documentation of samples to be analysed</p> <p>Questions to the scientists</p>

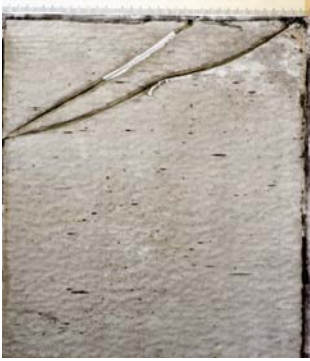
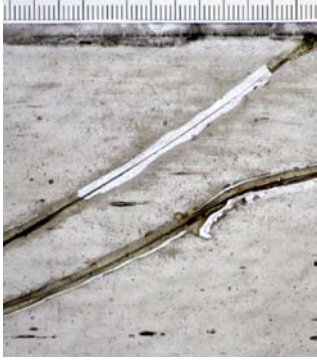
</div> <p>Glass bonded with epoxide resin – Epidian 53. Strongly yellow, bonding completely lost .</p> <p>Questions:</p> <ol style="list-style-type: none"> a. recent composition (as compared to modern resin, still available) b. reversibility tests <p>2</p> <div style="display: flex; justify-content: space-around;">
