<b>CONSTGLASS</b>

Data sheet for pilot objects

<b>Object:</b> CAN NXVII 3	<b>Date:</b> 10/05/10
----------------------------	-----------------------

OBJECT IDENTIFICATION	
<b>Site</b>	Canterbury, UK
<b>Building</b>	Canterbury Cathedral
<b>Location and orientation of the window</b> <b>Plan of the building</b>

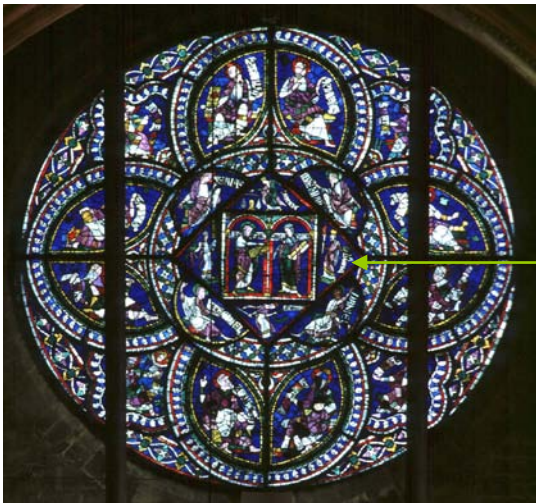
<div style="margin-left: 20px;"> <p>Oculus Diameter: 4.47m</p> <p>Test panel</p> </div> </div>

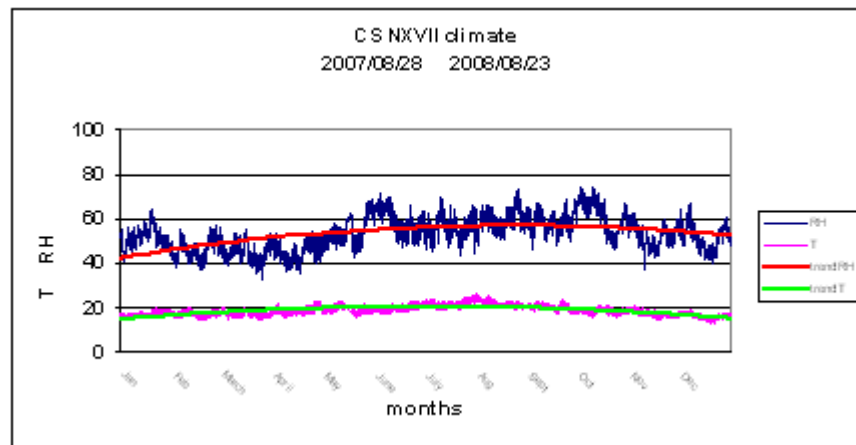
fig.1 CS NXVII climate

The plot shows that climatic conditions of the NXVII window are very stable through the whole year. Both T and RH levels are on the safe side and it seems that neither condensation nor wetness may occur.

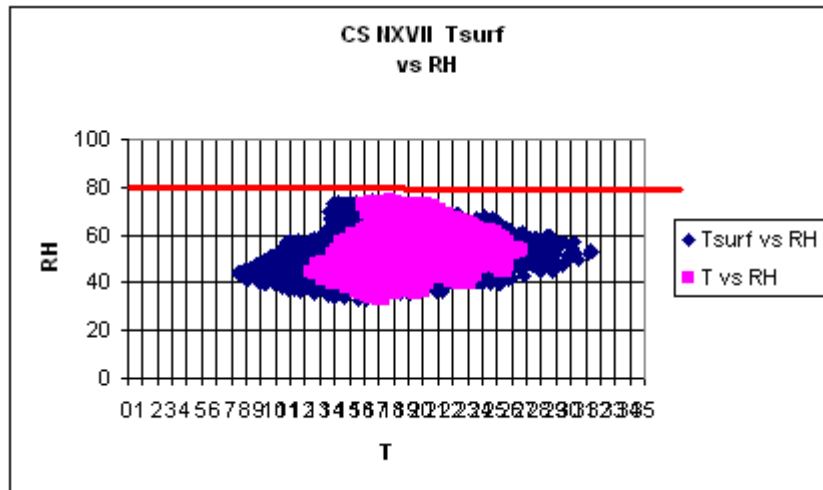
fig 2 CS NXVII climate: T vs. RH and Tsurf vs. RH

The graph depicted on fig. 2 visualizes the possibility of wetness of the glass occurring when  $T > 0^{\circ}\text{C}$  and  $\text{RH} > 80\%$ . Two sets of data: T (air) vs. RH and T surf vs. RH were compared. The graph shows, that, although a range of temperatures is wider for surface a surface, RH never reaches 80%. Taking into account possible differences between RH of air and RH close to surface, the possible wetness may occur, when T lies within 13 - 21  $^{\circ}\text{C}$ .

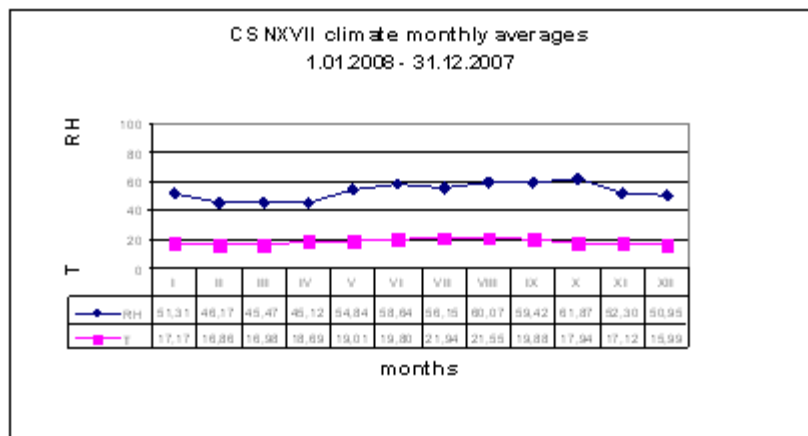
fig. 3. CS NXVII climate : monthly averages

The mean monthly values of T and RH confirm a good stability of NXVII window climate. The climate of window NXVII is quite stable and condition for stained glass windows are very good.

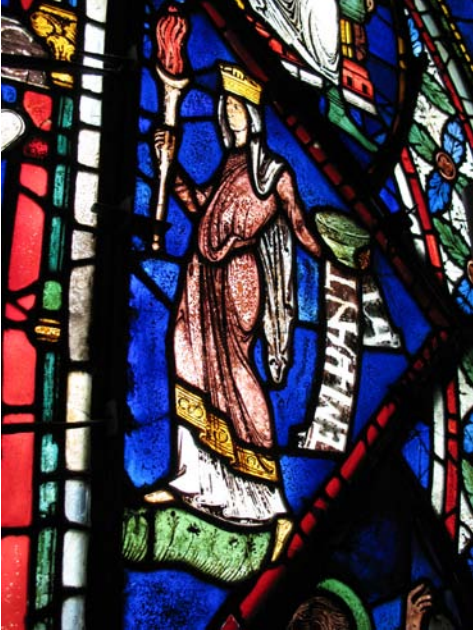
<p><b>Requirements for a safe removal in respect of minimal intervention</b></p>	<p>Handling with gloves, the panel was kept upright at all times.</p>
<p><b>Environmental causes for damage</b></p>	<p>Since the protective glazing was installed in 1984 there has been no condensation on the historic glass, though dust has accumulated on the surface.</p>
<p><b>Short report of removal</b></p>	<p>Handling with gloves, the panel was carefully removed from the frame. The putty seal had to be removed with a knife.</p> <p>In situ.</p>

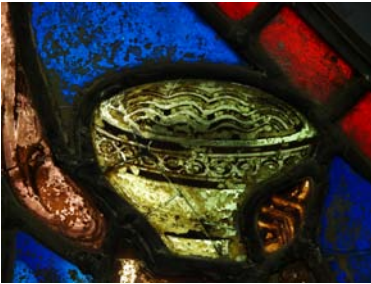
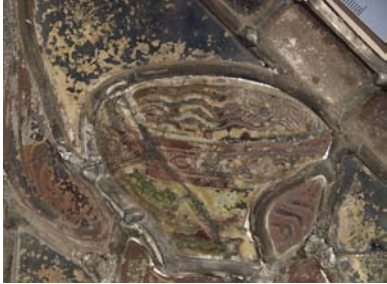
</div> <p>Wax swab for microbiological analysis.</p>
<p><b>Selection and documentation of samples to be analysed</b> <b>Questions to the scientists</b></p>	<div style="text-align: center;">

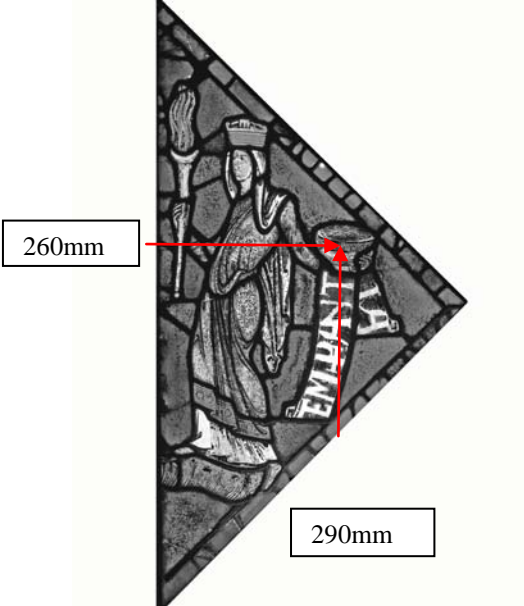
</div> <p>Sample was taken from the area show by the arrows. Has there been/ is there any microbial activity?</p>
