Data sheet for pilot objects

Object: CAN S.XXVIII South West Transept A16 **Date:** 03/12/09

Building Canterbury Cathedral

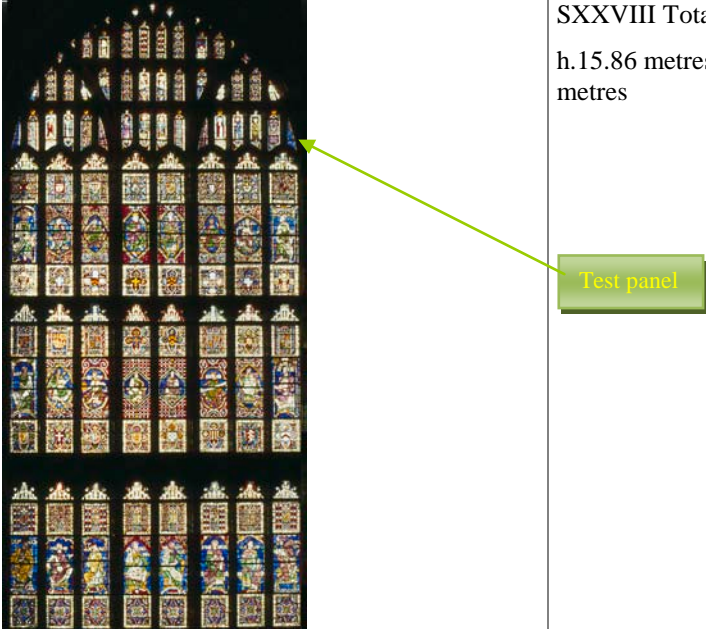
Description of the window opening (dimensions, number of lights; photo, test panel marked)

SXXVIII Total h.15.86 metres x w.7.32 metres
Date	Mostly 12 th Century with 13 th , 15 th , 19 th and 20 th century inclusions.	
Short description of the window (identification of subject, artist, workshop)	SXXVIII is one of the largest in the cathedral and contains some of the oldest panels. The window contains 22 of the surviving Ancestors of Christ in the main lights, which were moved from their original locations in the quire clerestory and from the Trinity chapel in the 18 th Century. Only the heads/canopies and 3 tracery panels originally belong to this window. The figure panels originate from the 12 th Century with 15 th Century heraldry while the tracery has an assembly of 12 th , 13 th , 19 th and 20 th century glass.	
Owner	Canterbury Cathedral	
Person(s) in charge	The Cathedral Studios	
Investigated panel (inventory number CVMA number, size)	SXXVIII A16

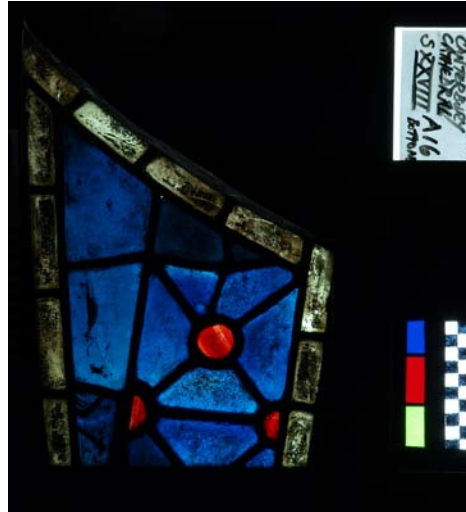
A16 Internal

Pictures of panel / glass in transmitted light

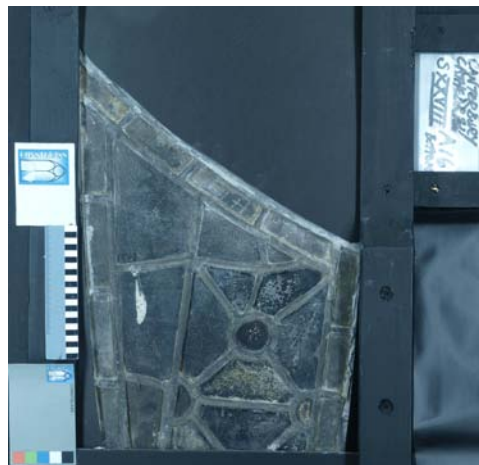
A16 Internal

Pictures of panel / glass in reflecting and raking light, internal and external surface

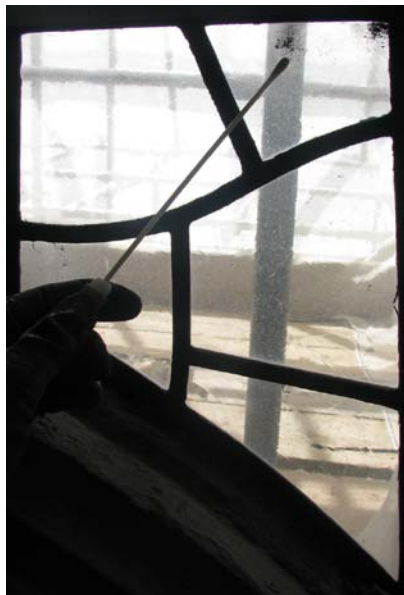
Taking swab from protective glazing panel

A sterile cotton bud was used to take a swab from the surface of one piece of glass on the stained glass panel, and one on the corresponding protective glazing panel, to be sent off for analysis.
