Data sheet for pilot objects

Object:	CAN S.XXVIII South West Transept D8	Date:	03/12/09
----------------	--	--------------	-----------------

OBJECT IDENTIFICATION	
Site	Canterbury, UK
Building	Canterbury Cathedral
Location and orientation of the window Plan of the building

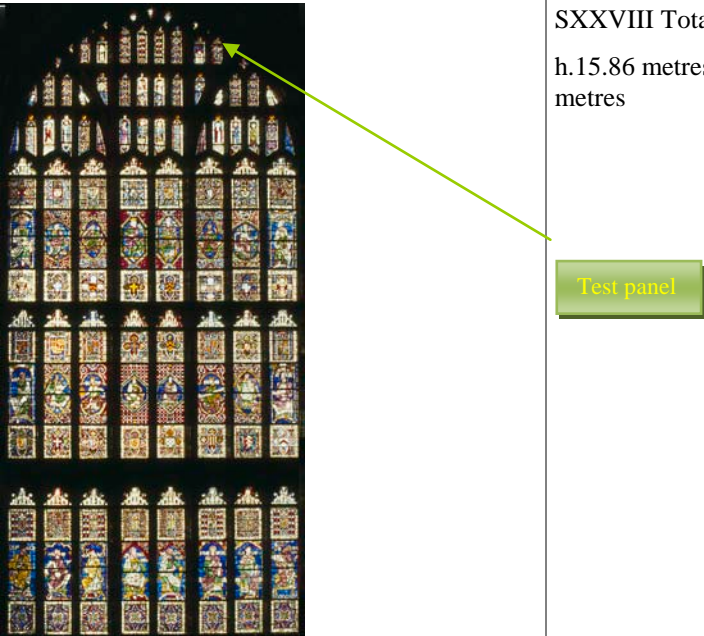
Description of the window opening (dimensions, number of lights; photo, test panel marked)

SXXVIII Total h.15.86 metres x w.7.32 metres
Date	Mostly 12 th Century with 13 th , 15 th , 19 th and 20 th century inclusions	
Short description of the window (identification of subject, artist, workshop)	SXXVIII is one of the largest in the cathedral and contains some of the oldest panels. The window contains 22 of the surviving Ancestors of Christ in the main lights, which were moved from their original locations in the quire clerestory and from the Trinity chapel in the 18 th Century. Only the heads/canopies and 3 tracery panels originally belong to this window. The figure panels originate from the 12 th Century with 15 th Century heraldry while the tracery has an assembly of 12 th , 13 th , 19 th and 20 th century glass.	
Owner	Canterbury Cathedral	
Person(s) in charge	The Cathedral Studios	
Investigated panel (inventory number CVMA number, size)	SXXVIII D8

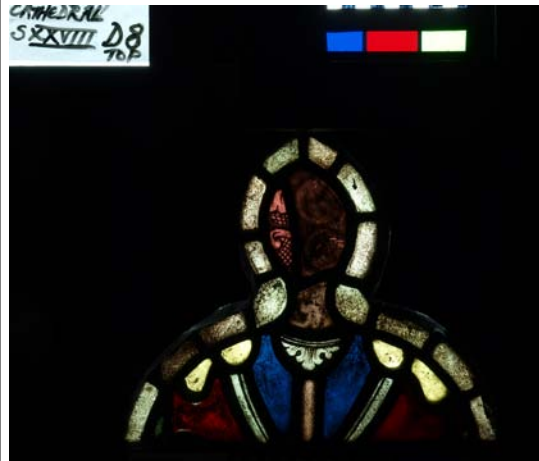
D8 Internal

Pictures of panel / glass in transmitted light

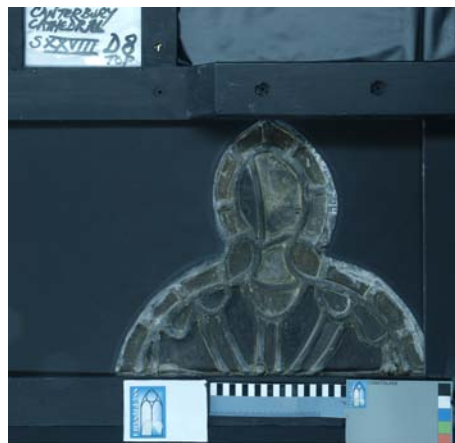
D8 Internal

Pictures of panel / glass in reflecting and raking light, internal and external surface

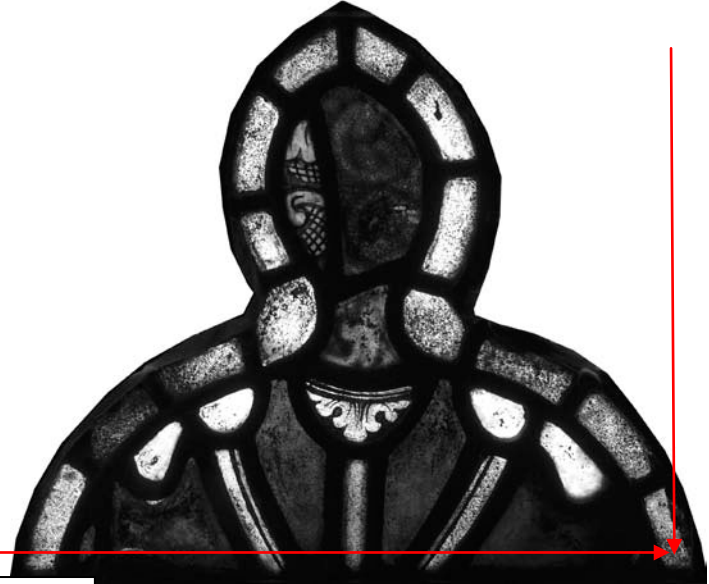
<p>260mm</p> <p>Sample was taken from the area show by the arrows.</p> <p>Question: Identification of coating.</p>
--	--

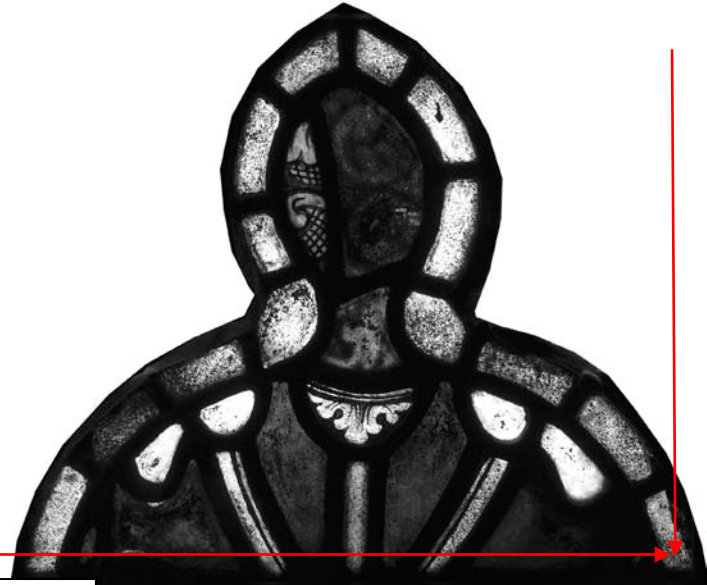
<p>260mm</p> <p>Sample was taken from the area show by the arrows. Is there any microbial activity on the glass?</p>
Selection and documentation of areas for reversibility tests or reactivation tests	<p><i>Diagrams, records and pictures, including a separate data-sheet for every area consigned for reversibility or reactivation test.</i></p> <p>Attention: Do not carry out any treatment on the testing area! Do not touch!</p>
