Data sheet for pilot objects

Object: CAN sVII 1	Date: 10/05/10
---------------------------	-----------------------

OBJECT IDENTIFICATION	
Site	Canterbury, UK
Building	Canterbury Cathedral
Location and orientation of the window Plan of the building	South aisle

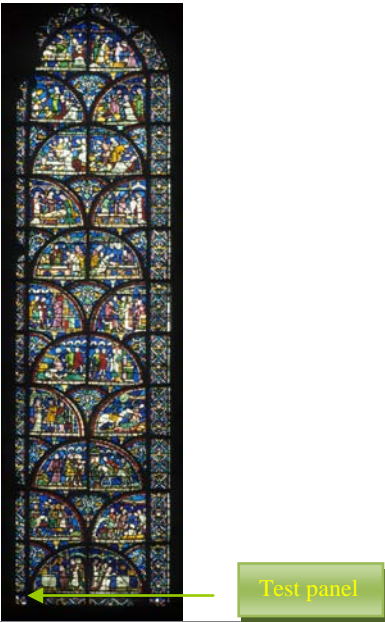
Description of the window opening (dimensions, number of lights; photo, test panel marked)

One light window. Total width: 1.57m Total height: 6.7m Test panel installed at 2.28m from the floor
Date	Probably around the same time as or not long after nII (in or not long after 1213).	
Short description of the window (identification of subject, artist, workshop)	The last window in the Becket Miracle window series, consisting of sixty-three panels. Single lancet.	
Owner	Canterbury Cathedral	
Person(s) in charge	The cathedral Studios, Canterbury	
Investigated panel (inventory number CVMA number, size)	sVII 1

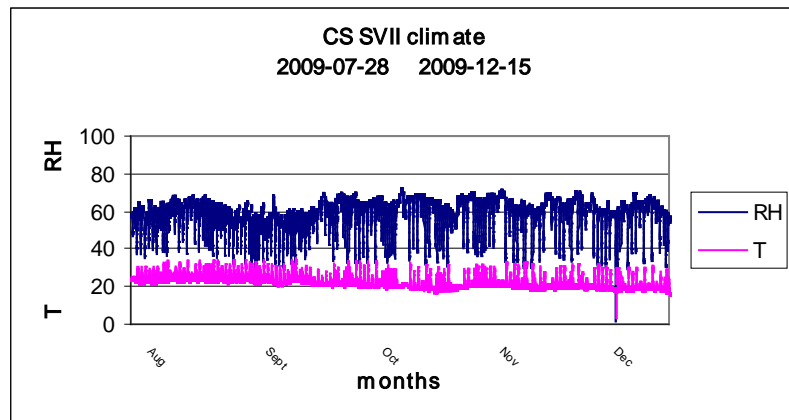
fig.1 CS SVII climate

The graph shows that climatic conditions of the SVII window are very stable through the measurement period and, both T and RH levels are on the safe side and it seems that neither condensation nor wetness may occur.

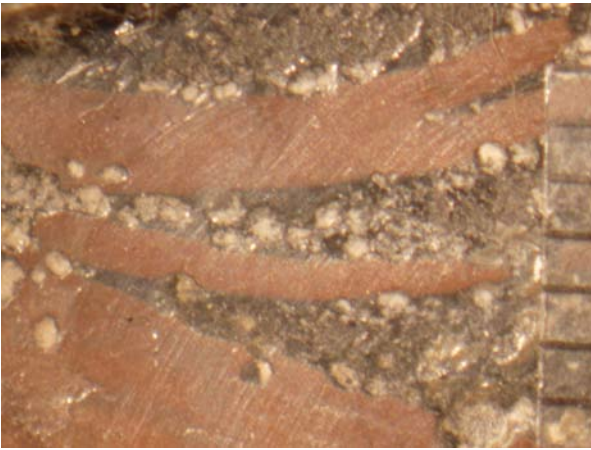
Selected damages

<p>Wax coating on painted decoration.</p>
Selection and documentation of samples to be analysed Questions to the scientists

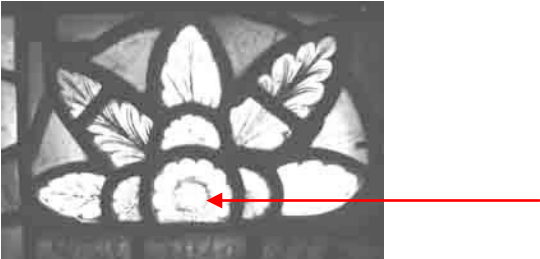
<p>Arrow indicates location of sampling. Can the wax be identified?</p>
