CONSTGLASS

Data-sheet Cologne / BS 31

Object: Cologne Cathedral	Date: 05. 12. 2008
----------------------------------	---------------------------

Window "Adoration of the Magi", 1846

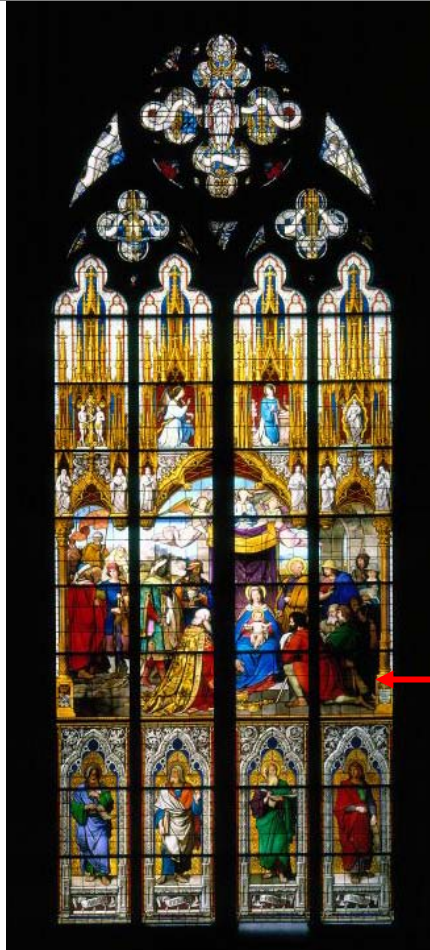
Test panel 4d

4 lancet window with tracery
total height: circa 14 m
total width: circa 4,90 m
height per lancet: circa 10 m
width per lancet: circa 1,12 m

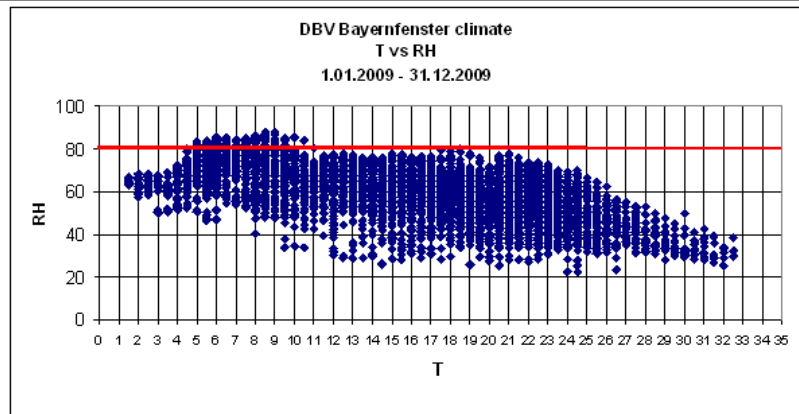
fig 2. DBV Cologne s XXII climate: T vs RH

The graph depicted on fig. 2 visualizes the possibility of wetness of the glass occurring when $T > 0\text{ }^{\circ}\text{C}$ and $\text{RH} > 80\%$. The graph shows, that wetness may occur only for short periods, when the temperature is low (5 to 11 $^{\circ}\text{C}$), although in much wider range (5 to 21 $^{\circ}\text{C}$) the danger of wetness may occur.

The climatic conditions of the window s XXII are under direct influence of outer climate, although, particularly in terms of temperature, it is in average, rather stable. The scatter plot (fig.2) however shows a certain danger of wetness of the glass surface. The visual radiation (fig. 4) shows an unusual phenomenon - contrary to typical rising of light level in summer and lowering in winter, in the case of window s XXII the radiation is the other way round: high in winter and lower in summer. It is interesting to note, that UV radiation is on fairly stable level throughout the year. An explanation of this phenomenon is, without knowing the situation of the window, impossible. If there is no mistake in measurements, it seems, that there is an additional source of light during darker periods of the year.

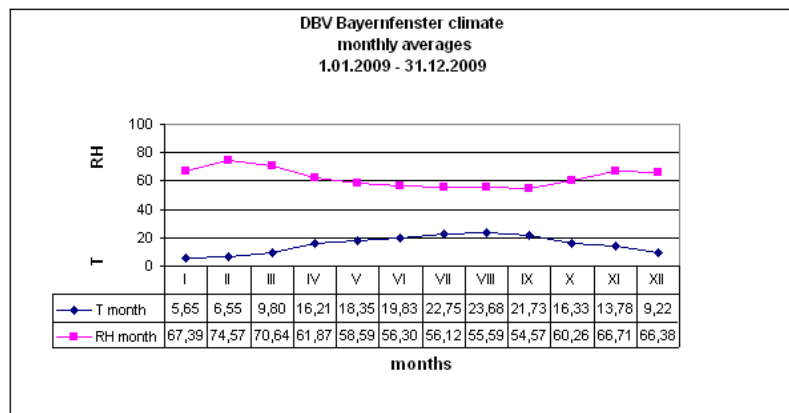
fig. 3. DBV Cologne s XXII climate: monthly averages

The mean monthly values of climate data follow the trend lines of plot 1 and also show, that probability of wetness occurrence is higher in the colder seasons of the year.

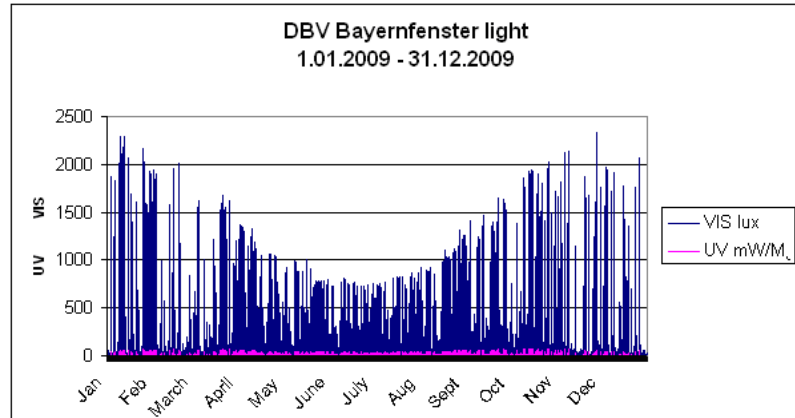
fig. 4. DBV Cologne s XXII visible and UV light levels

The lowest level of the light occurs in summer. The phenomenon, rather astonishing at the first glance may be caused by high sun path in summer, leading to shading the area where logger was situated. The UV level is very low through the all year.

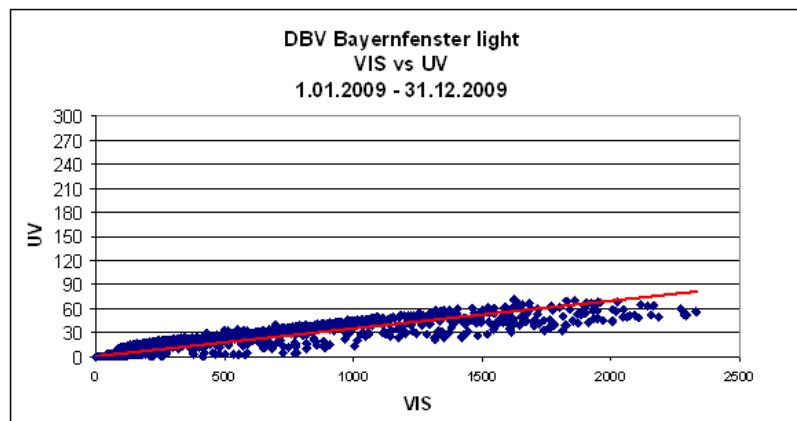
fig 5. DBV Cologne s XXII light:VIS vs. UV

The graph shows, that the UV level is low, as compared to visible light. The intensity of visible light has a very large span, although the low intensities are more common than the higher ones.

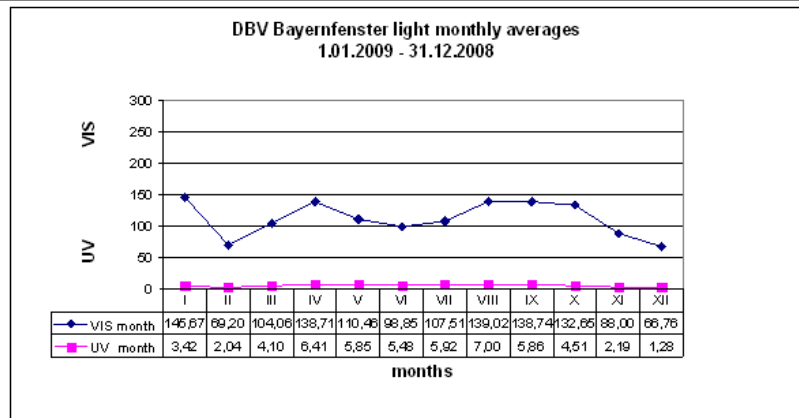
fig. 6. . DBV Cologne s XXII light: monthly averages

The UV radiation is low and rather stable throughout the year. The visible light shows highest values in January, April and Autumn months. The lowest levels occurred in February, November and December.

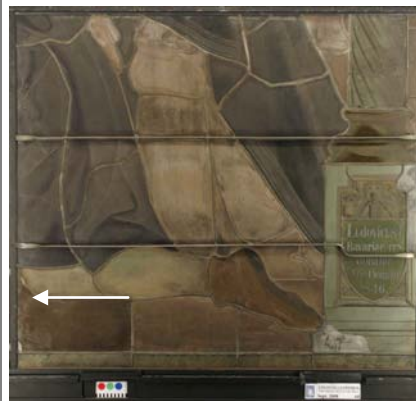
internal face

The internal surface coated with BS 31 seems to be in a good condition. But several parts of the coating (thick application) look somewhat milky as if air bubbles were enclosed. Under microscope you can see crizzled areas.
