Data sheet for pilot objects

Object:	Bourges Cathedral, BOU_b4p9	Date:	18.01.2010
OBJECT IDENTIFICATION			
Site	Bourges (France, 18)		
Building	Saint-Etienne Cathedral		
Location and orientation of the window Plan of the building	Ambulatory, bay 4

CONDITION REPORT / DOCUMENTATION IN THE WORKSHOP

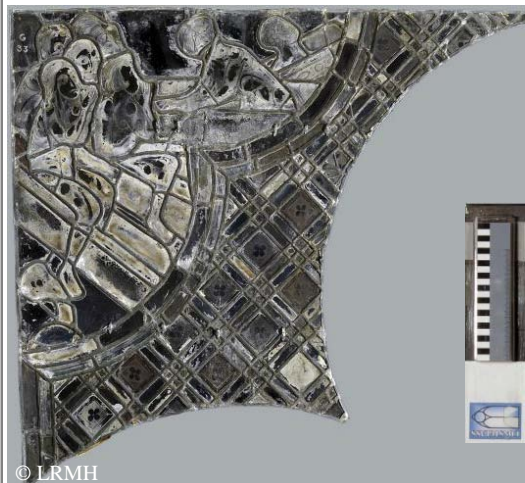
Panel 9, internal surface

Glass: it seems to be less deteriorated on the internal surface. There are some holes of alterations dispersed. Marks of a previous cleaning with a metal brush on some pieces, but no alteration is visible in the marks.

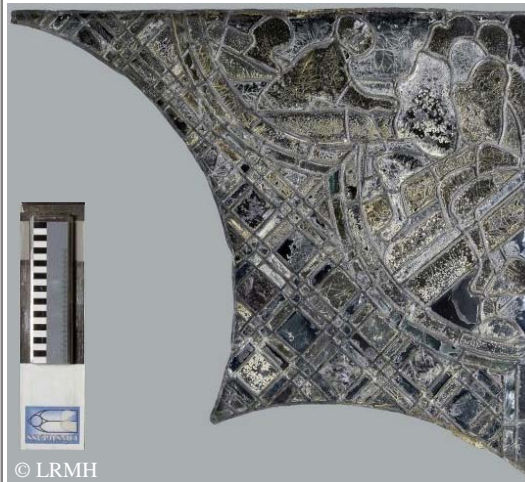
Panel 9, external surface

Deposits: thick and hard white (brownish) deposit on most of the pieces, possibly from distemper or mastic residue. These deposits often conceal the corrosion of the glass.
