Data sheet for pilot objects

Object: REF. PARISH CHURCH, TEST - GLASS **Date:** 12.01.2009

Site Burgdorf BE (Switzerland)

Building Ref. Parish Church

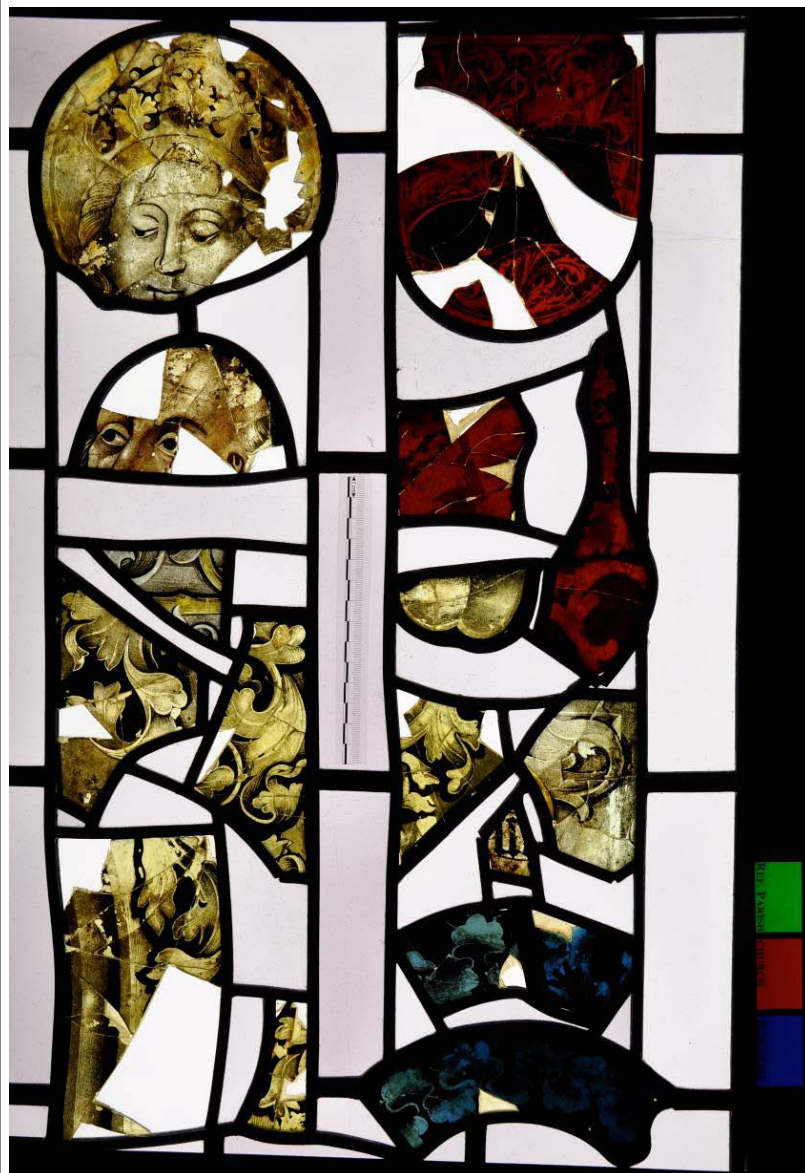
**Pictures of panel /
glass in transmitted
light**

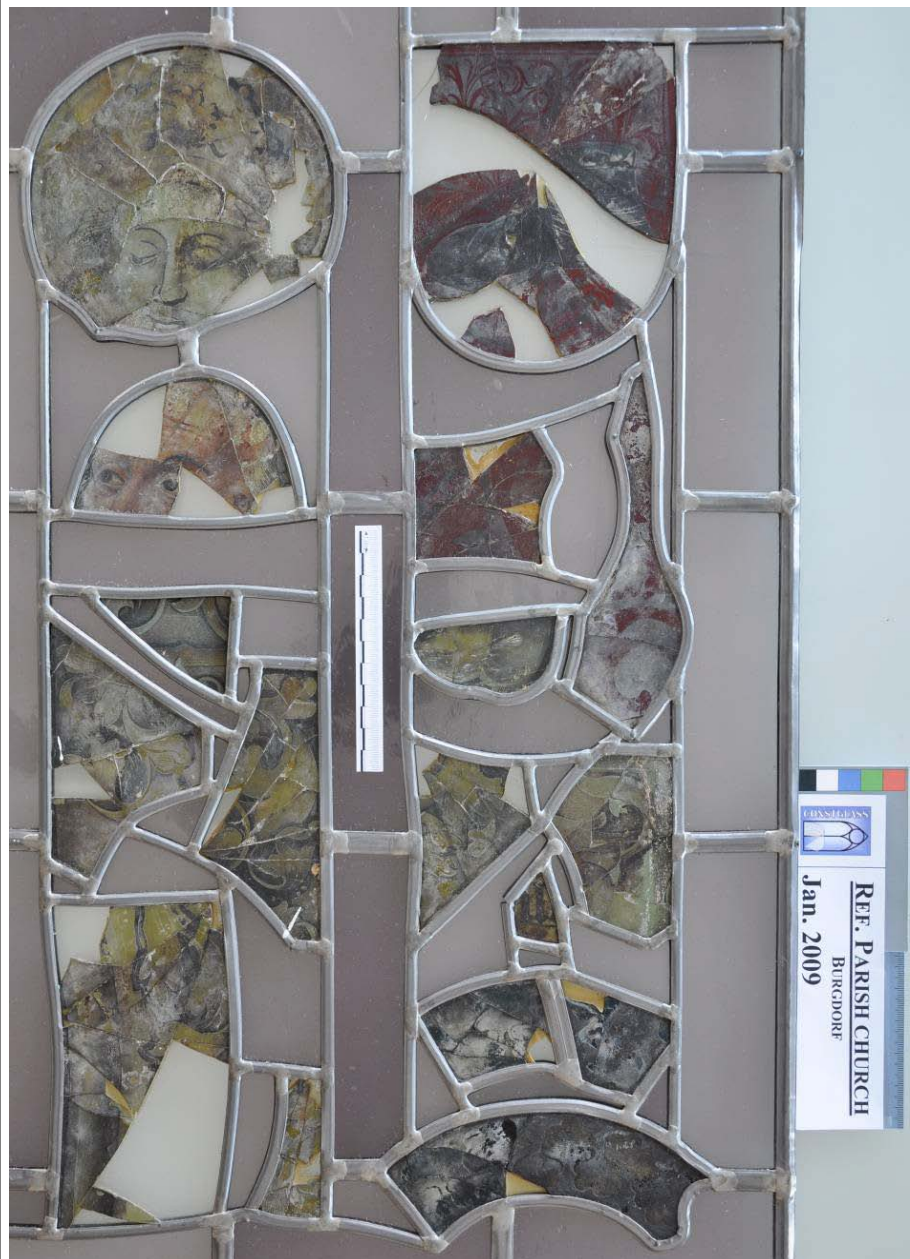
Pictures of panel in reflecting and raking light, internal surface.

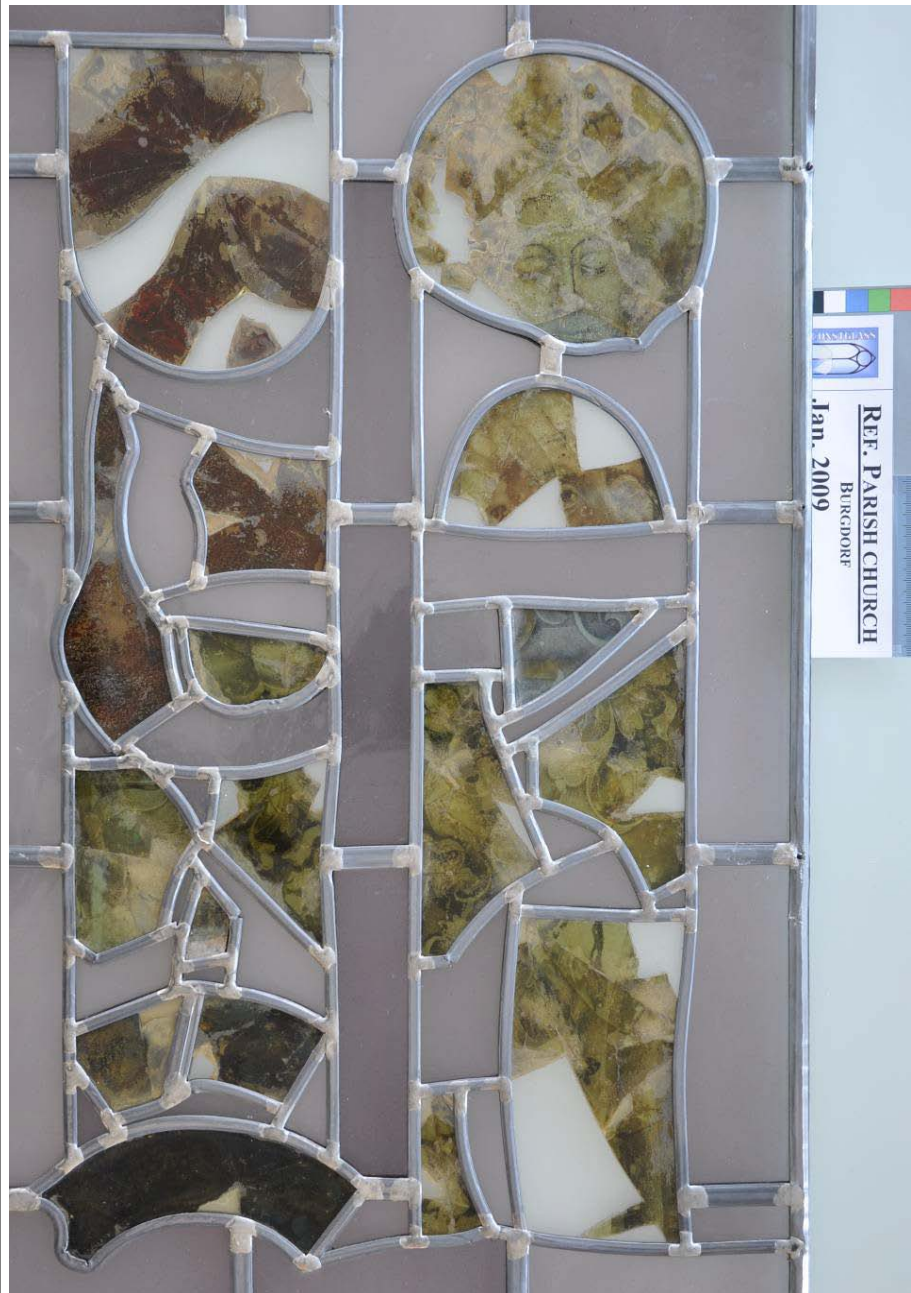
Pictures of panel in reflecting light, external surface.

object (if possible with microscope)	<p>Short: The glass is in stable condition. On the (laminated as well as open) external surfaces some pitting corrosion.</p> <p>The paint is stable. Some paint loss.</p> <p>The lead is a perfect condition. The putty is in a good condition.</p> <p>The Araldite® is yellowing and in some places loses adhesion / flakes off, showing clearly different types of deterioration.</p>
Selected damages	<ul style="list-style-type: none">● fragment without doubling / pitting corrosion□ selected damages for samples / pitting corrosion in Araldite®

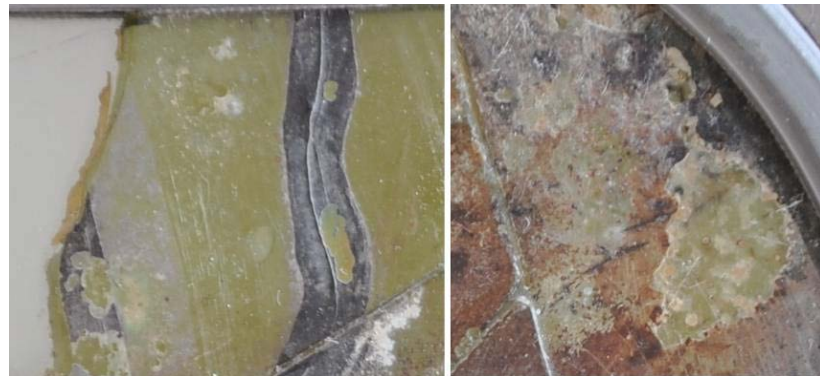
Selection and documentation of samples to be	<p>Is there a difference between the pitting corrosion with Araldite® and without?</p>

What is the impact of the resin on the glass surface and painting?
