CONSTGLASS

Data sheet for pilot objects

Object: CAN NXVII C1	Date: 10/05/10
-----------------------------	-----------------------

OBJECT IDENTIFICATION	
Site	Canterbury, UK
Building	Canterbury Cathedral
Location and orientation of the window Plan of the building

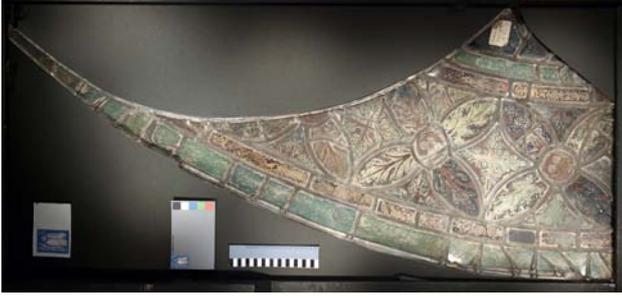
Pictures of panel / glass in reflecting and raking light, internal and external surface

Examination of the object (if possible with microscope)	Please see the attached conservation record.
Selected damages	Test applications of SZA, Ormocer/Paraloid® B72 1/1 and Paraloid® B72.
