Data sheet for pilot objects

Object: CAN nII 7	Date: 10/05/10
--------------------------	-----------------------

OBJECT IDENTIFICATION		
Site		Canterbury, UK
Building		Canterbury Cathedral
Location and orientation of the window Plan of the building		North aisle, Trinity chapel

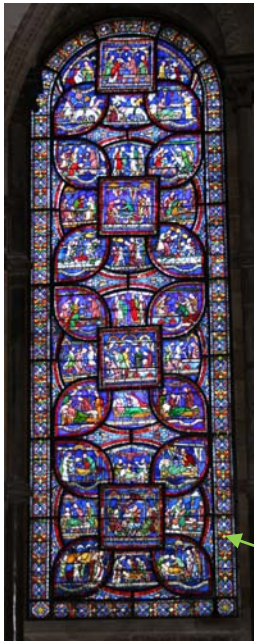
<p>One light window Total width: 2.25m Total height: 7.0m Test panel installed at 1.82m from floor</p>
<p>Date</p>		<p>Probably in or not long after 1213.</p>	
<p>Short description of the window (identification of subject, artist, workshop)</p>		<p>The Becket Miracle Window. A tightly organised, repeating pattern of square, petallic, hatchet-shaped, ornamental and rectangular border panels. The fourth window in the Becket Miracle series. There are six stories, based on Benedict's Book IV. The miracles concern blindness, leprosy, drowning, madness and the Plague.</p>	
<p>Owner</p>		<p>Canterbury Cathedral</p>	
<p>Person(s) in charge</p>		<p>The Cathedral Studios</p>	
<p>Investigated panel (inventory number CVMA number, size)</p>		<p>nII 7 874 x 225 mm</p>
