Data sheet for pilot objects

Object: CAN sVII 4	Date: 10/05/10
---------------------------	-----------------------

OBJECT IDENTIFICATION	
Site	Canterbury, UK
Building	Canterbury Cathedral, Trinity Chapel ambulatory
Location and orientation of the window Plan of the building

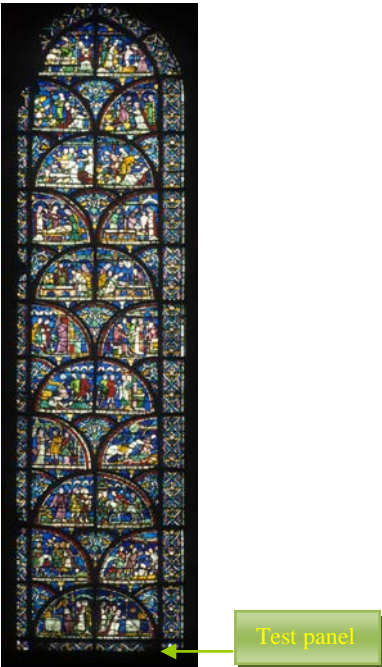
Description of the window opening (dimensions, number of lights; photo, test panel marked)

One light window. Total width: 1.57m Total height: 6.7m Test panel installed at 1.68m from the floor
Date	Probably around the same time as or not long after nII (in or not long after 1213).	
Short description of the window (identification of subject, artist, workshop)	The last window in the Becket Miracle window series, consisting of sixty-three panels. Single lancet.	
Owner	Dean and Chapter of Canterbury	
Person(s) in charge	The Cathedral Studios	
Investigated panel (inventory number CVMA number, size)	sVII 4
