Data-sheet Klausen

Object: Parish Church in Klausen (Eifel)	Date: 15. 12. 2008
---	---------------------------

OBJECT IDENTIFICATION	
Site	Klausen (Germany)
Building	Parish and Pilgrimage Church
Location and orientation of the window	Axial window in the choir, faced to the east

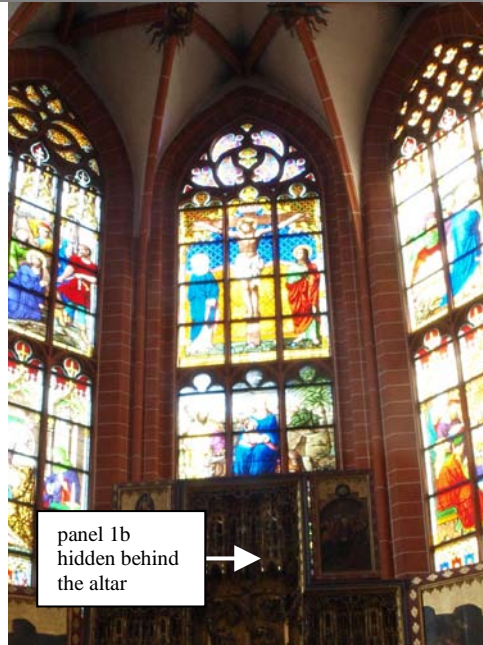
Description of the window opening (dimensions, number of lights, test panel marked)

3 lancet window with tracery
total height: circa 11 m
total width: circa 3 m
height per lancet: circa 8,50 m
width per lancet: circa 90 cm

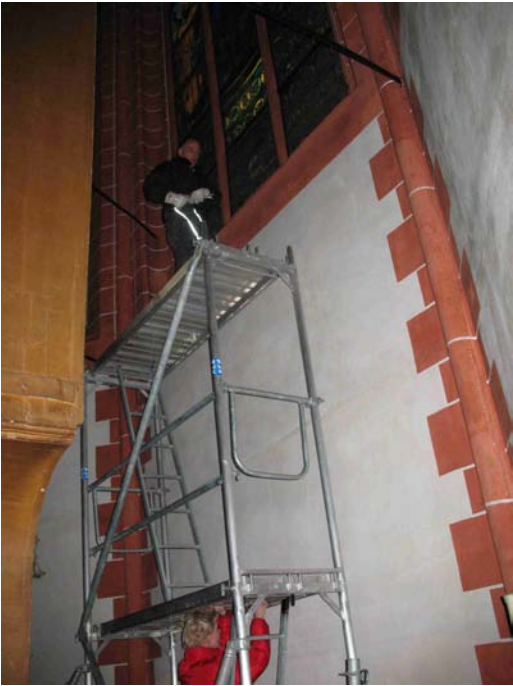
INSPECTION OF THE SITE BEFORE REMOVAL (WITH PICTURES)	
Requirements for a safe removal in respect of minimal intervention	
Environmental causes for damage	
Short report of removal	<p>The internal mounted panel was easy to remove. It required a scaffold and a 17'' wrench.</p>

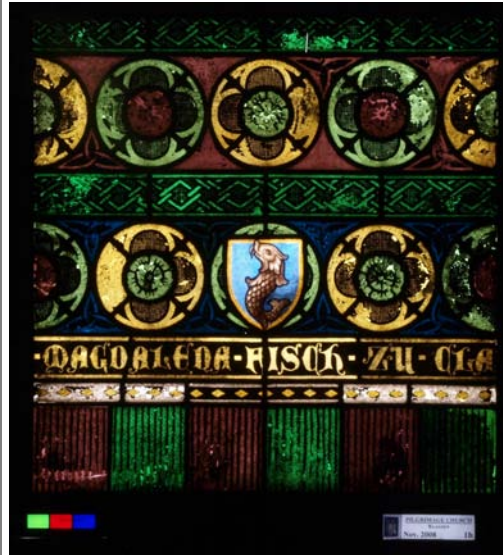
Pictures of panel / glass in transmitted light

The internally coated glass is obviously in a good condition compared to 1991. Only some small particles of the paint became loose. Unfortunately, in 1991, the company which carried out the general conservation treatment (Firma Binsfeld, Trier, D) did not pay much regard for the SZA/Ormocer®-treated test panel, especially for the endangered paint. They applied several cello-tapes on the internal face, maybe for securing cracks (we do not know why). Two of the cello-tapes were detached by somebody; here the SZA/Ormocer®-treated contours were badly damaged.

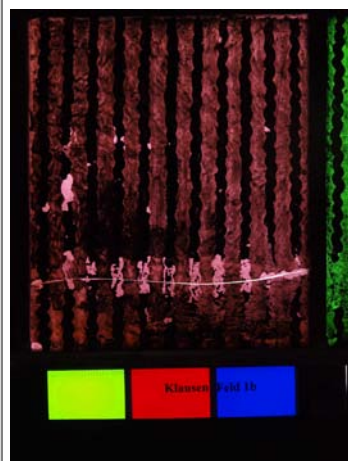
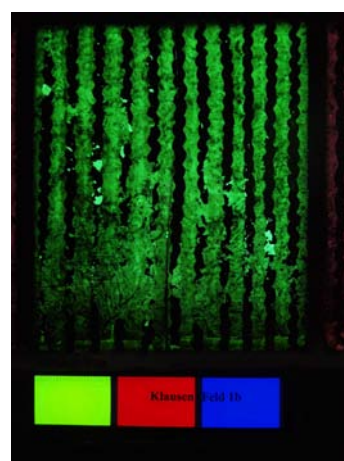
internal face, transmitted light

<p>sample no. 1: KLA_Ormocer_1</p> <p>sample no. 2: KLA_SZA_1</p> <p>sample no. 3: KLA_Untreated_1</p> <p><u>Conservators Questions:</u></p> <ul style="list-style-type: none"> - What about the today's condition of the conservation materials? - How is the adhesion between glass and the materials? - Is there any reaction between the paint and the coating materials? - Can you detect and differentiate the various materials (glass / Ormocer®/ SZA)? - Is there any penetration of Ormocer® respectively SZA into the paint layer? - Is there any chance to remove the materials without damaging the paint underneath?
Selection and documentation of areas for reversibility tests or reactivation tests	<p>All 3 glass samples can be used for tests.</p> <p>If necessary the pieces can be cut smaller, but the procedure <u>must</u> be executed exclusively by Kathrin Wittstadt!</p> <p>Sample KLA_SZA_1 was separated in July 2009 for the investigations in 3 samples:</p> <p>KLA_SZA_separtated_1 KLA_SZA_separtated_2 KLA_SZA_separtated_3.</p>
